**REPORT OF THE STANDING COMMITTEE OF EXPERTS
ON FAILURE OF EHV TRANSMISSION LINE TOWERS
(OCTOBER 2016 – MARCH 2018)**

भारत सरकार
Government of India
केन्द्रीय विद्युत प्राधिकरण
Central Electricity Authority
विद्युत मंत्रालय
Ministry of Power
नई दिल्ली
New Delhi

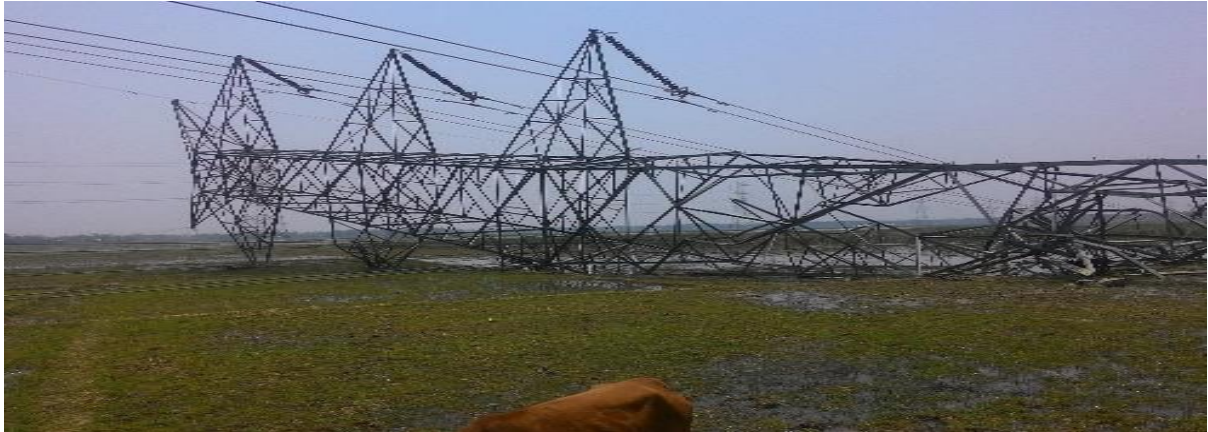
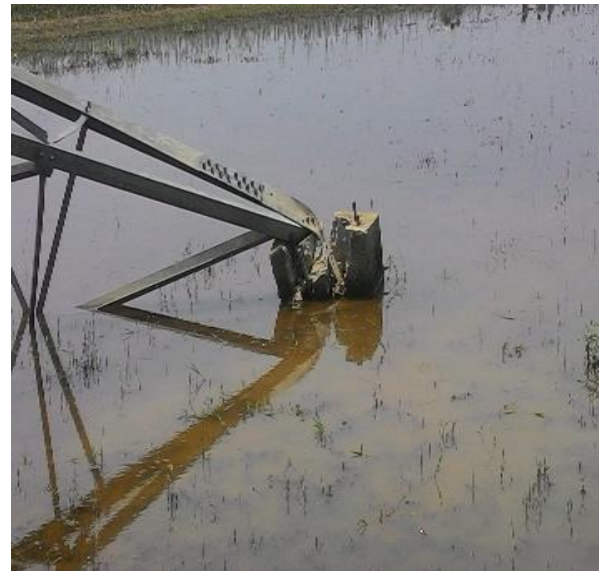
were partially submerged in water. Tack welding of the bolts was not done and some of the bolts in butt joints in leg members were missing. Few numbers of holes were left unfilled in some members of the tower. Anti-climbing device was not provided.

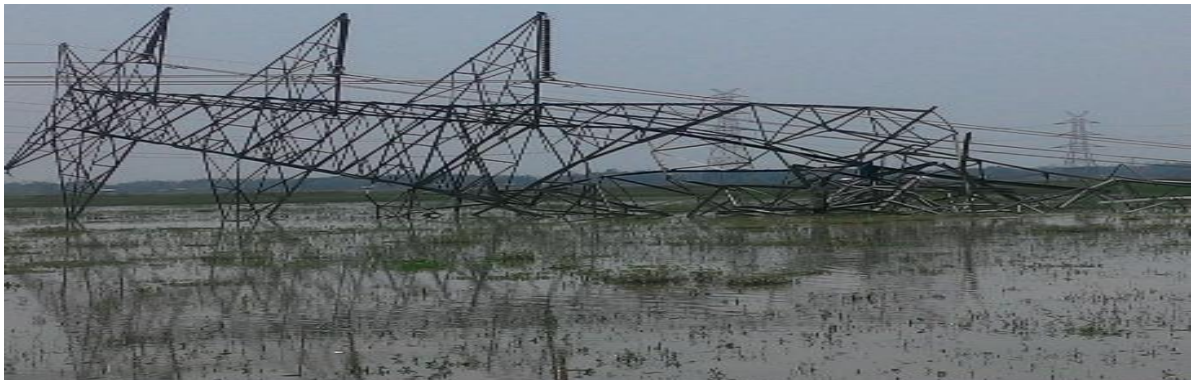
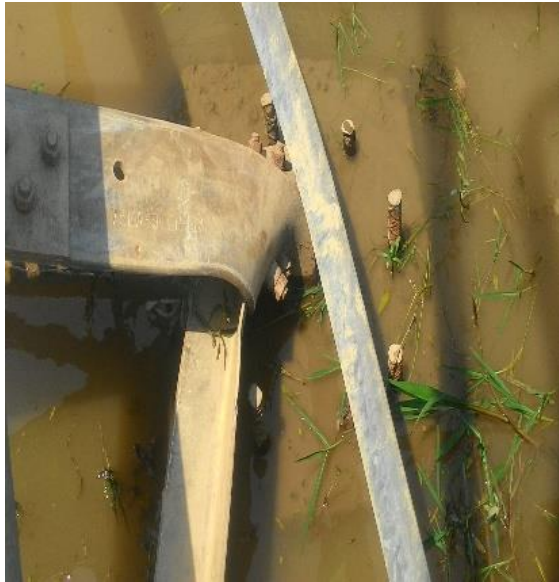
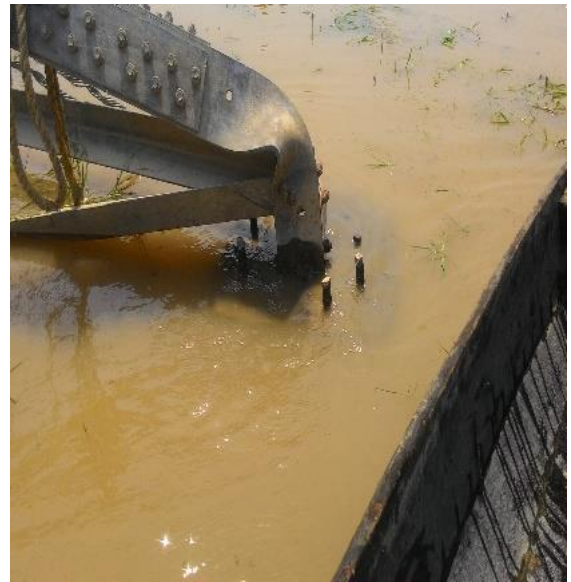
- b. **Tower at location no. 125 (DA+0)** was completely collapsed on ground to the left side in transverse direction when observed facing P K Bari. Foundations of the tower were partially submerged in water. Tack welding of bolts and nut was not done. Tower legs had sheared from the 2nd panel level. The stubs were bent. ACD was not provided. Coping of chimneys was not done and steel reinforcement was protruding from them. One foundation chimney had cracked. As reported that the location was used to be water logged during rains.

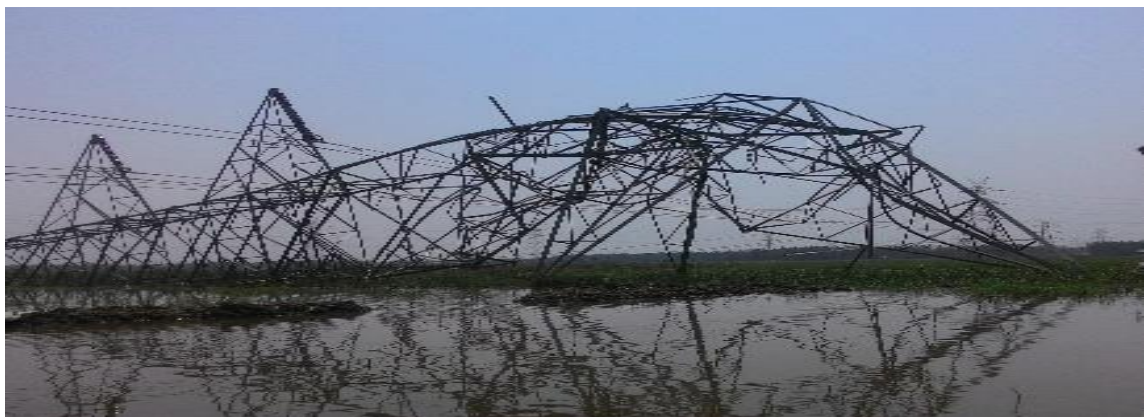
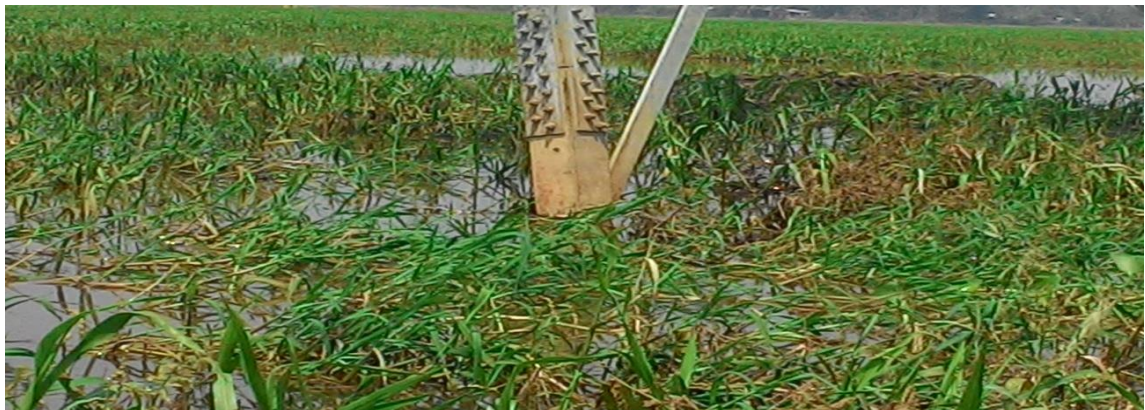
- c. **Tower at location no. 126 (DA+0)** was completely collapsed on ground to the left side when observed facing P K Bari. All the four legs were submerged in water. The tower got bent from 2nd panel level and had fallen in transverse direction to the line. Tack welding of bolt & nuts was not done. Cover plate was not provided in one of the joint in all the four legs. The two stubs were bent and the remaining two were intact. Few numbers of bolts were missing in the leg joints. The stubs got rusted due to water logging.

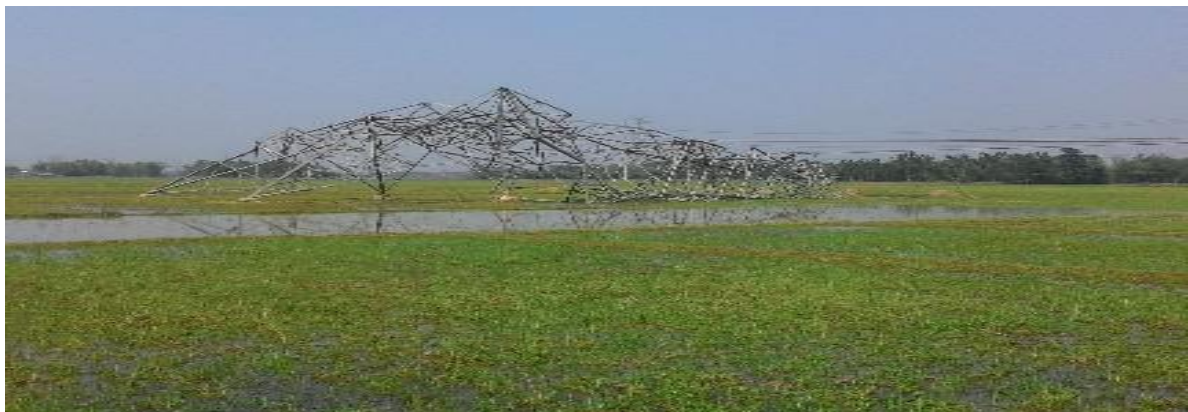
- g. **Tower at location no. 138 (DA+0)** had collapsed from the stub level towards left side when observed facing P K Bari. Unplugged holes were present in the members of the tower which were. Coping of the chimneys were not done. Two stubs were bent & other two were intact. Few numbers of bolts in the joints of bracings and leg members were missing. Anti-climbing device was not provided. The area surrounding the failed tower was water logged.

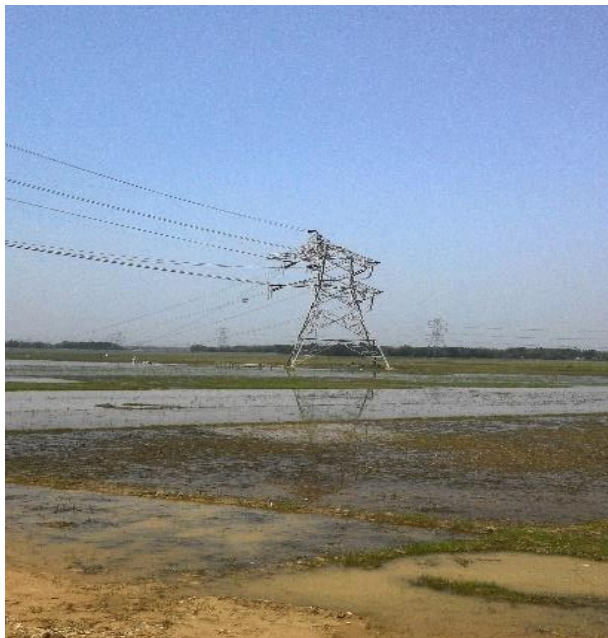
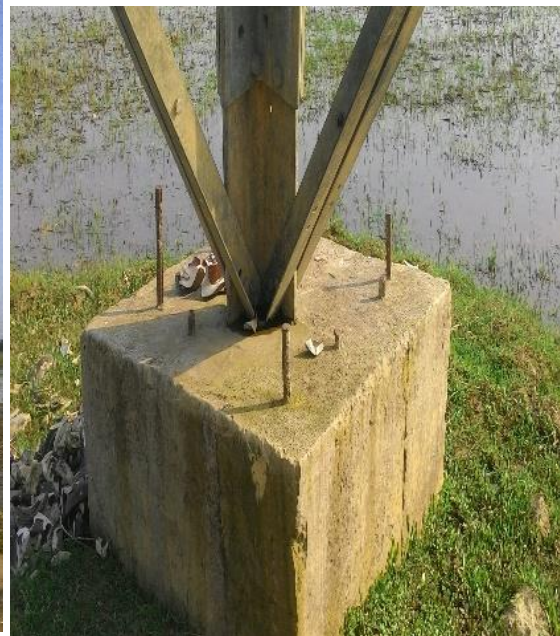
- h. **Tower at location no. 139 (DD+0)** was in erect position with members above bottom cross arm level twisted and bent towards right side in transverse direction when observed facing P K Bari. Members above first section got buckled & the foundations were intact. Coping of chimneys was not done. Steel reinforcement was protruding from three of the chimneys. A number of holes in tower members were not plugged. Few numbers of bolts were missing in

the leg member joints. A trolley which might have been used while stringing the conductors was not removed from the wires and was still hanging in air. The line was charged without removing this trolley.

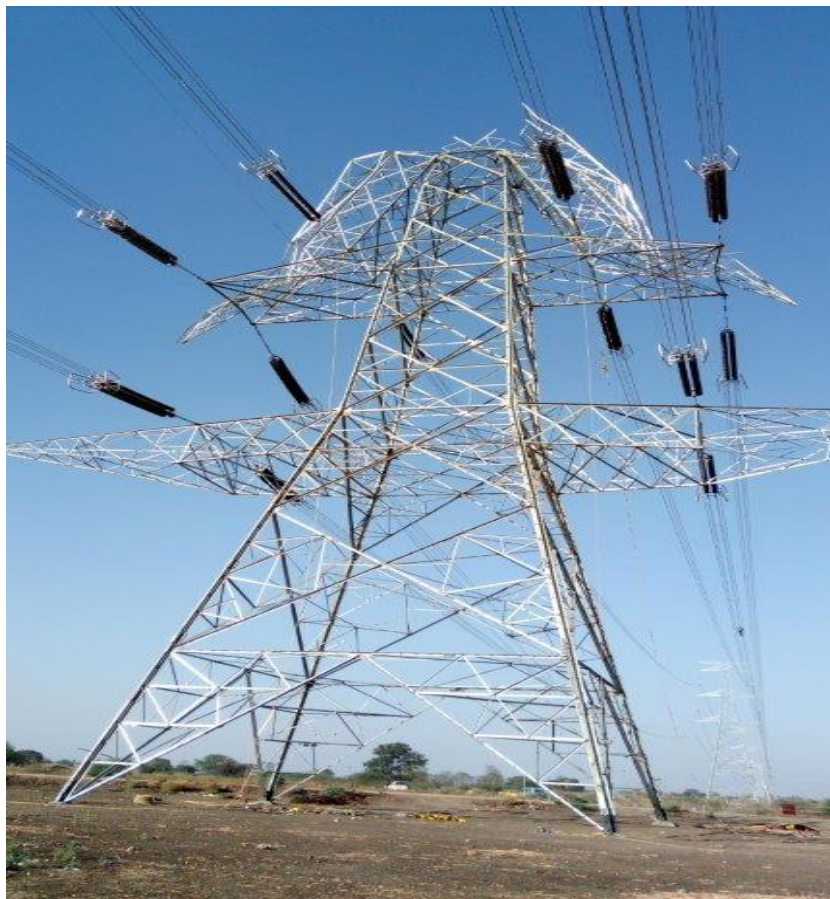
A team comprising of PGCIL officials visited the tower at location no. 175/8(DCT+0) and observed that the tower was damaged above bottom cross arm level. It was further observed that transverse belt connecting upper member of top cross arms failed under tension (i.e. mark no.809 & 810 section HT 100*100*8) and subsequently earth wire peak wire and top cross arms got damaged. Any missing bolts/ nuts/ tower parts was not observed.

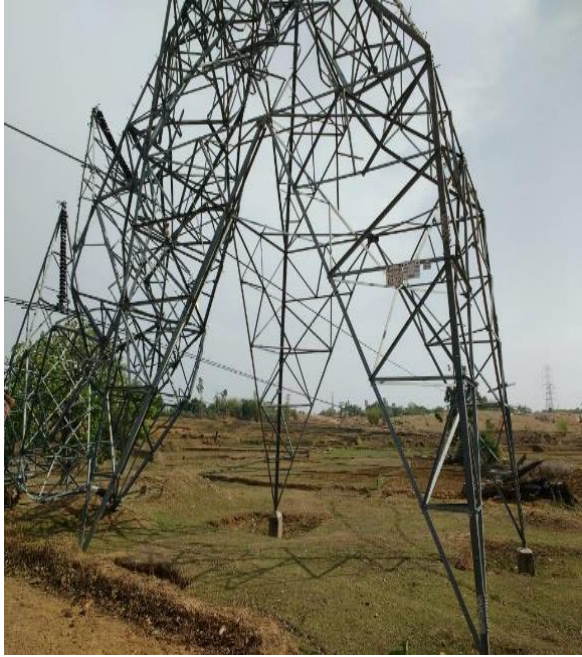
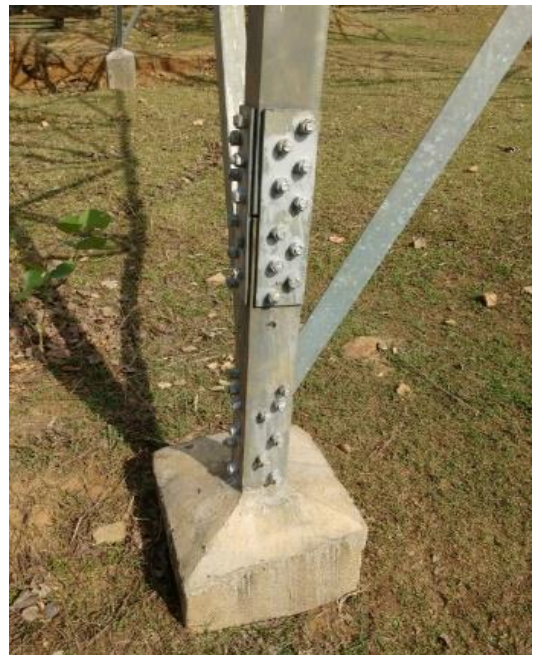
- a. **Tower at location no. 172(DA+0)** had collapsed above first panel in transverse direction. The foundations were intact. Hip bracings, Tack welding of bolt & nut, Anti-theft bolts and coping of chimneys were provided. Earthing arrangement of the tower was not visible.

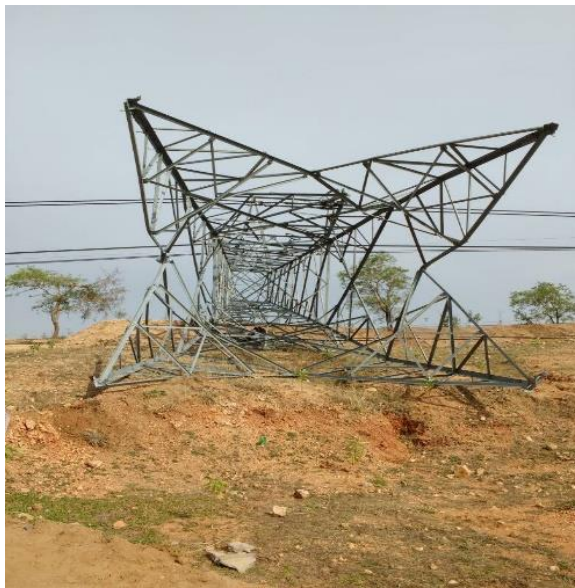
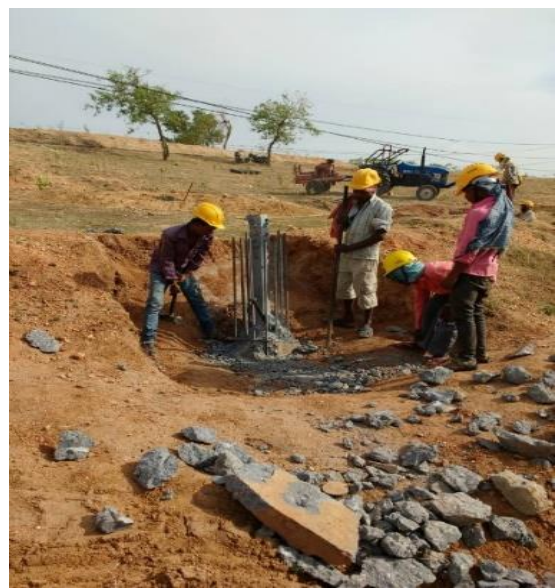
- b. **Tower at location no. 173 (DA+0)** collapsed at stub level and fell in the transverse direction. At the time of inspection, it was observed that the tower was removed by gas cutting and repairing of all the four chimneys was in progress to replace the damaged stubs. No missing of members observed.

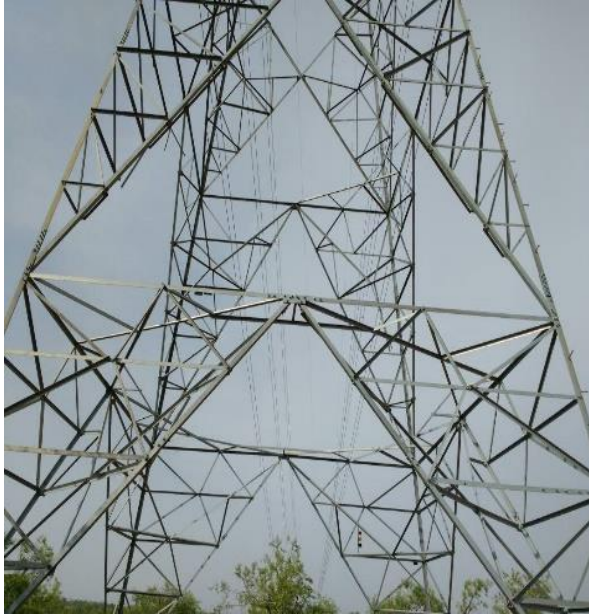
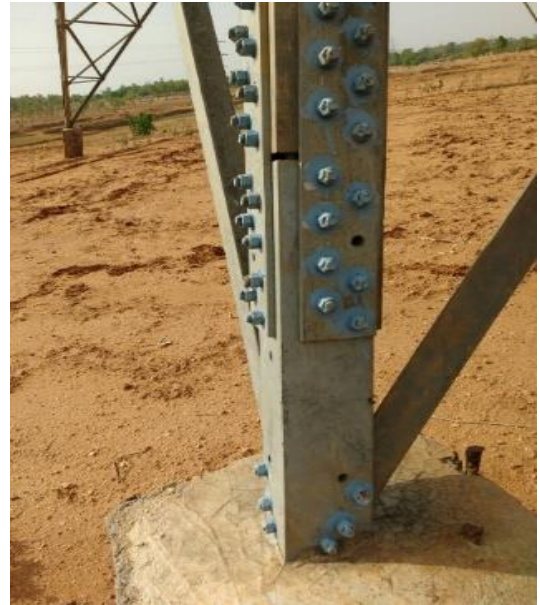
- c. **Tower at location no. 174(DA+6)** and all its four foundations were intact. Few bolts were missing in joints. Some extra holes in leg members were not plugged with bolt & nut. ACD was not available. Some of the redundant members were disconnected from the joints and were hanging. Copping of chimneys was not done properly.

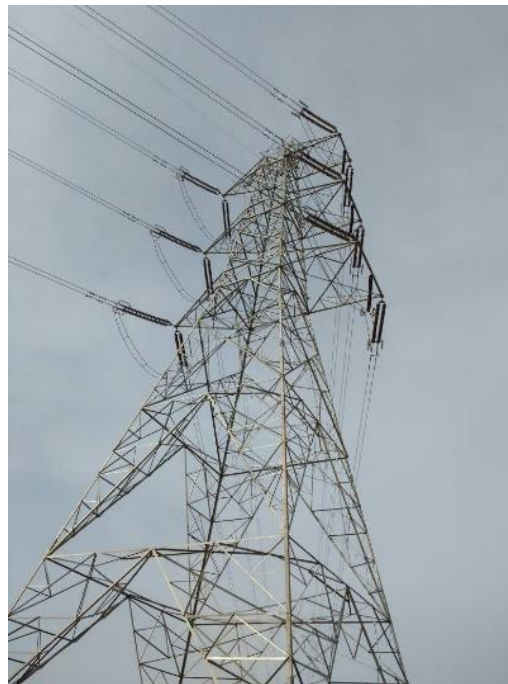
- d. **Tower at Location No. 175 (DD+9)** was in erect condition and one of the peaks of the tower was damaged. Few bolts were missing at joints. Some extra holes in leg members were not plugged with bolt & nut. Foundation reinforcement was exposed. Copping of chimneys was not done properly.

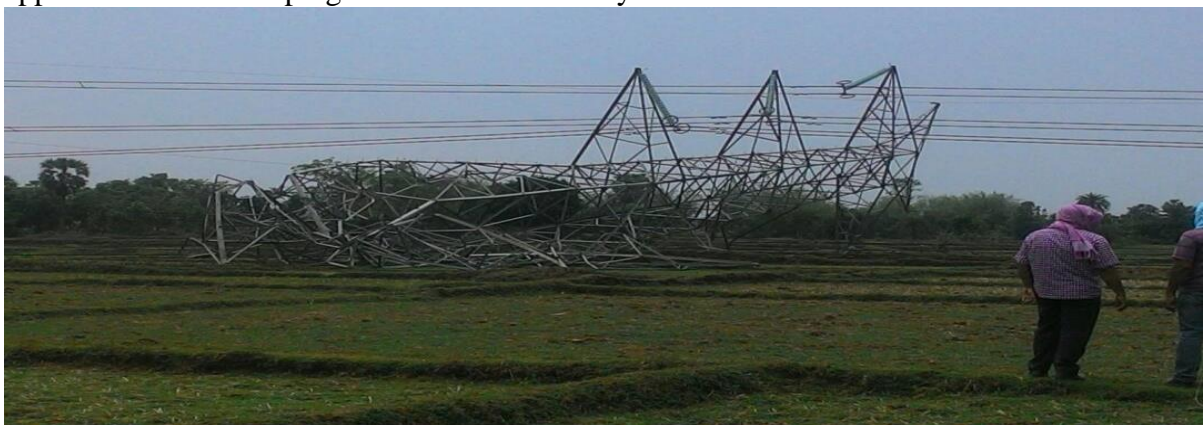
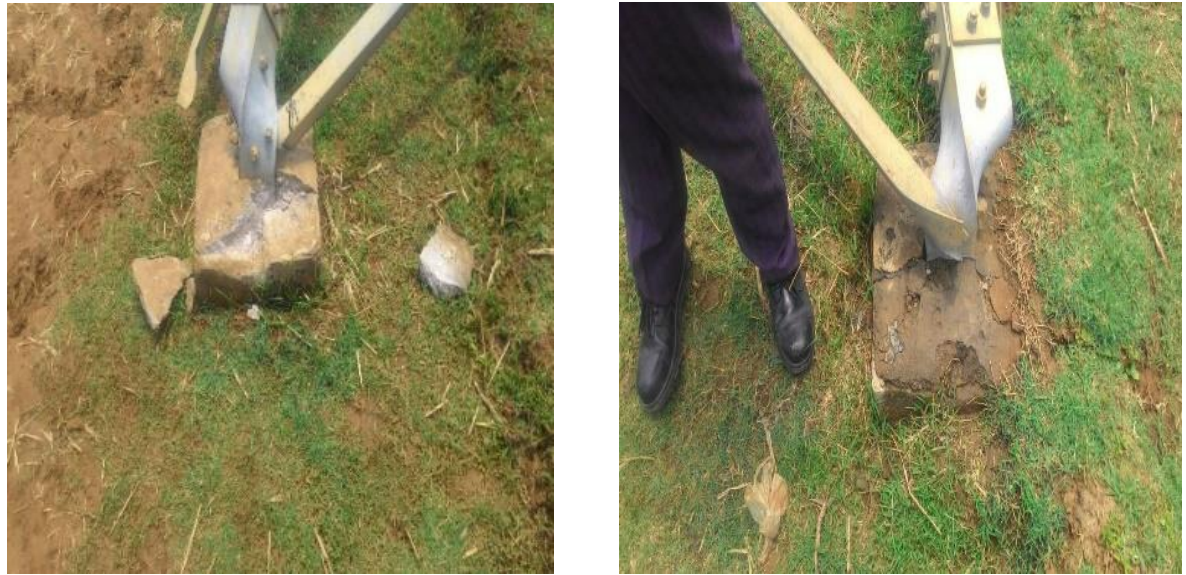
- a. **Tower at location No. AP 142 (DA+0)** was completely collapsed in transverse direction towards right side of the transmission line when watched towards Farakka Substation and was lying on the ground. Two of the stubs were bent, third stub got bent & sheared and fourth stub was covered under the ground. Minor damages were observed in the chimneys and few cracks appeared on them. Coping of two of the chimneys was not done.

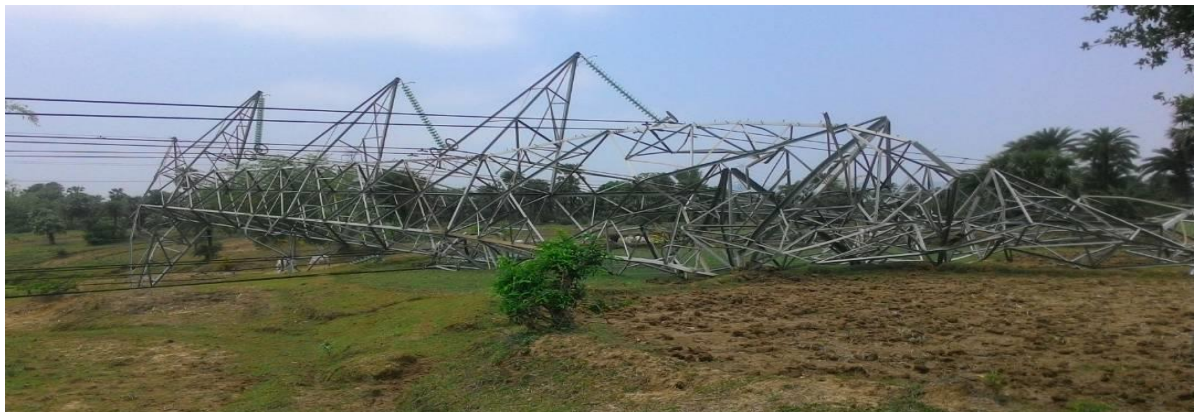
- b. **Tower at location no. AP 143 (DA+0)** was completely collapsed in transverse direction towards right side of the transmission line when watched towards Farakka Substation and was lying on the ground. Three of the stubs were bent and the fourth stub got bent and sheared. Anti-climbing device was not provided. Signs of flash over at right bottom cross arm insulator were observed. Minor damages were observed in one of the chimneys. The foundations were found to be intact.

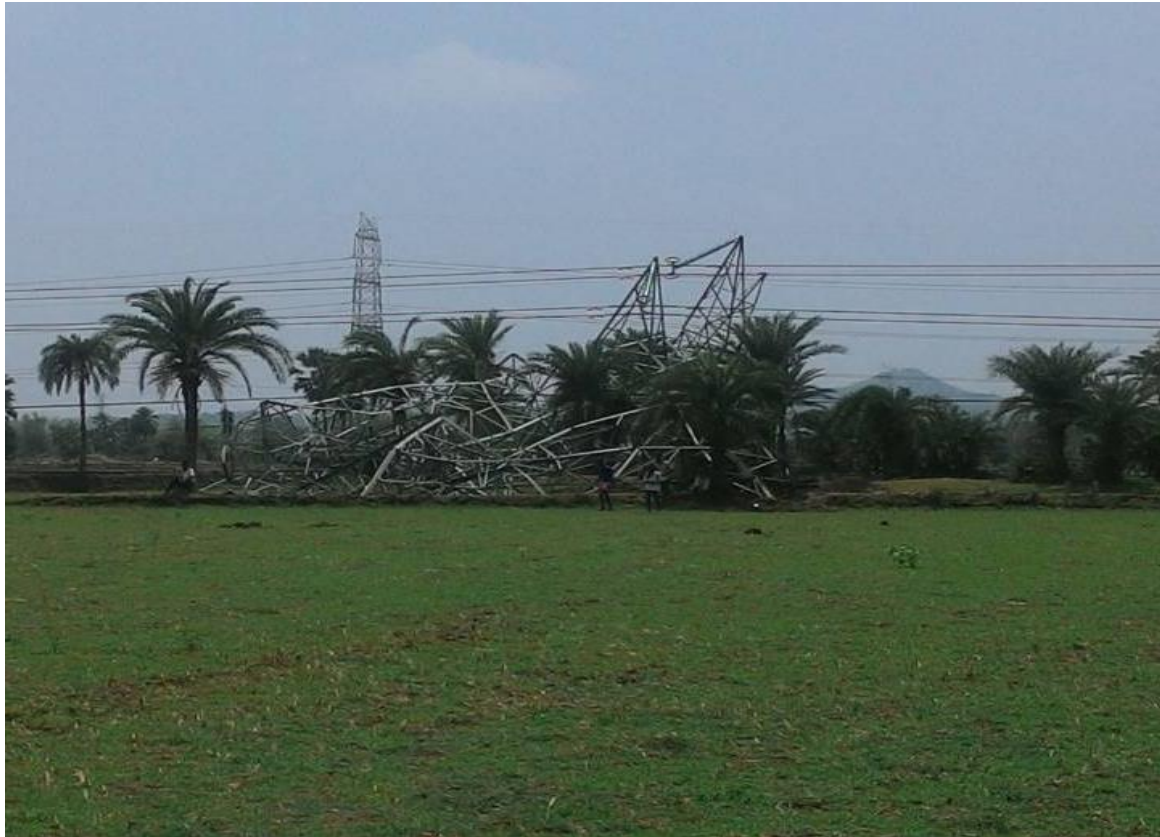
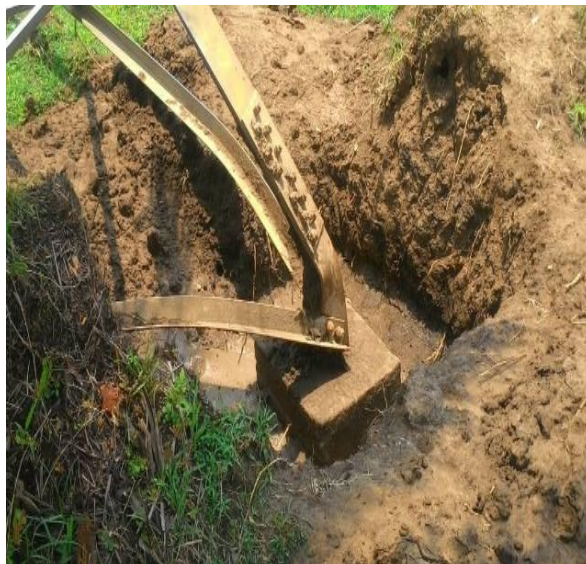
- c. **Tower at location no. AP 144 (DA+6)** was completely collapsed towards right side of the transmission line when watched towards Farakka Substation and was lying on the ground. Three of the stubs were bent and fourth stub was not visible as it was under the ground. It was

observed that three of the tower legs were recently excavated. The members of the leg and connecting bracings were rusted. Anti-climbing devices was not provided. The foundations were found to be intact.

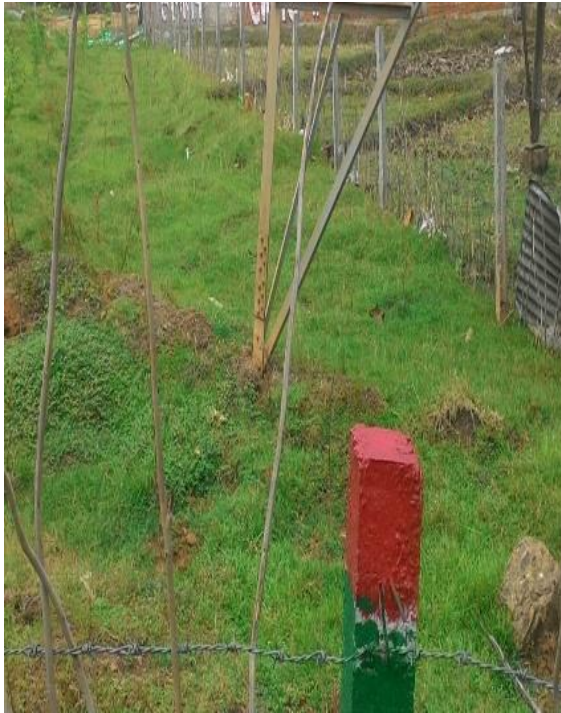
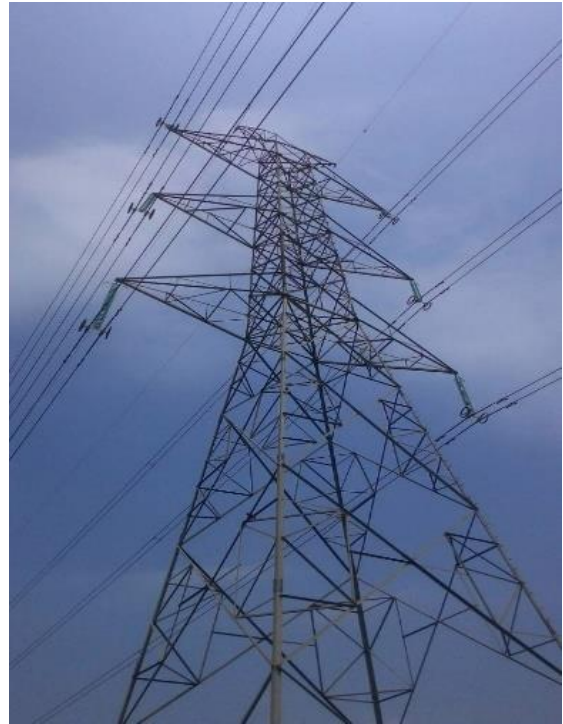
- d. **Tower at location no. AP 145 (DA+ 0)** was located at the vicinity Borio-Barhait Road and had one of the span crossing the road. The tower was in erect position. Right side peak of the tower, when watched towards Farakka, got buckled. The Copping of the chimneys were not done. All the chimneys were intact. One of the chimney was under the ground. Few no. of bolts in the joints of bracings were missing. Anti-climbing device was not provided.

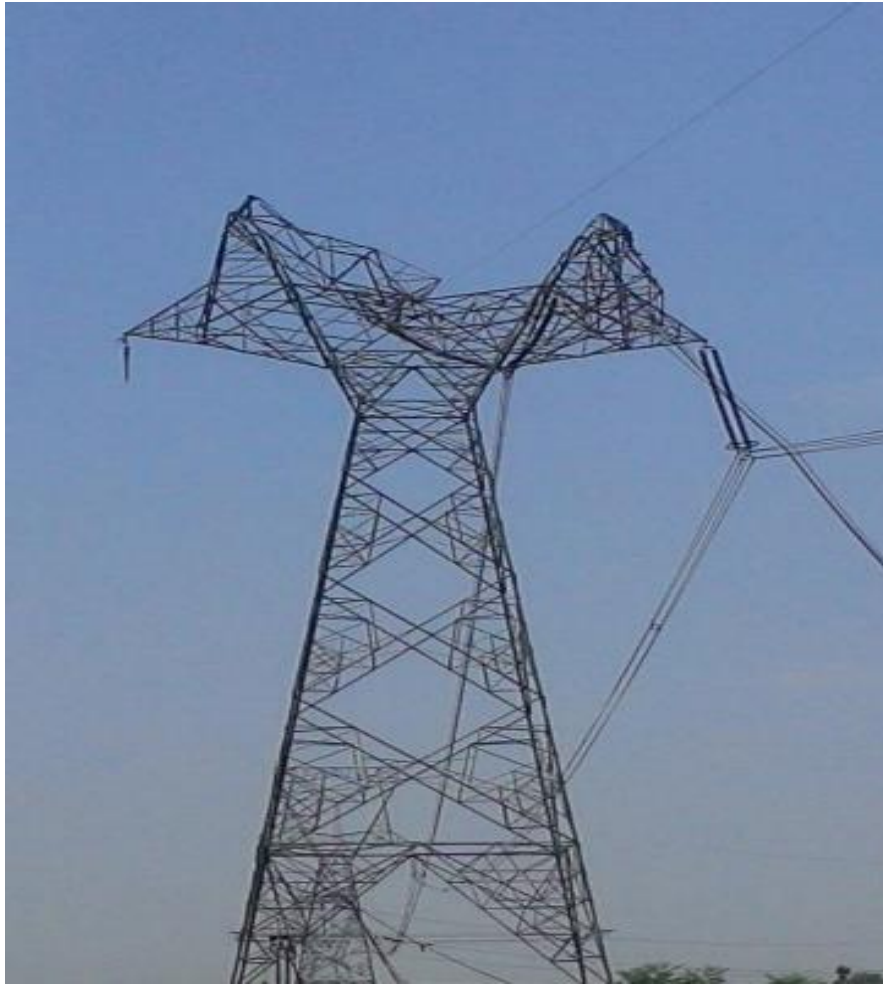
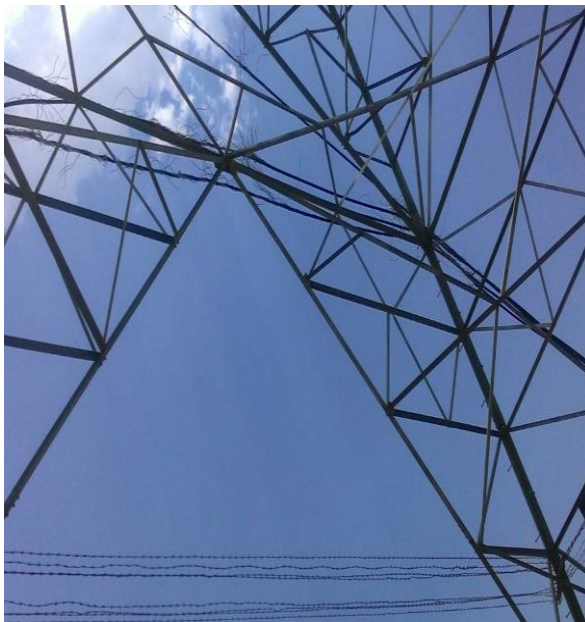
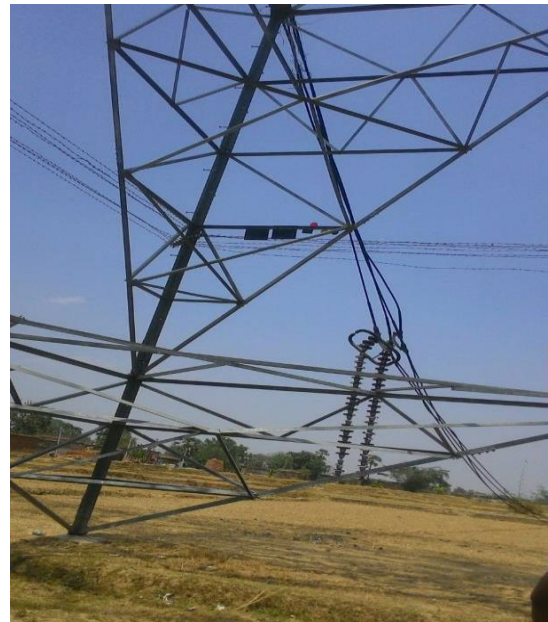
- Tower at location no. AP 65 (A+3)** was in erect position and the delta section of the tower was bent and converged towards the tower body in the direction towards Varanasi substation. It was observed that the insulator of the left cross arm had broken and the conductor bundle had completely detached from the insulator and was resting on the tower body at the first panel level. The right side conductor was attached to the insulator at the cross arm level. The foundations of tower were covered with sand.

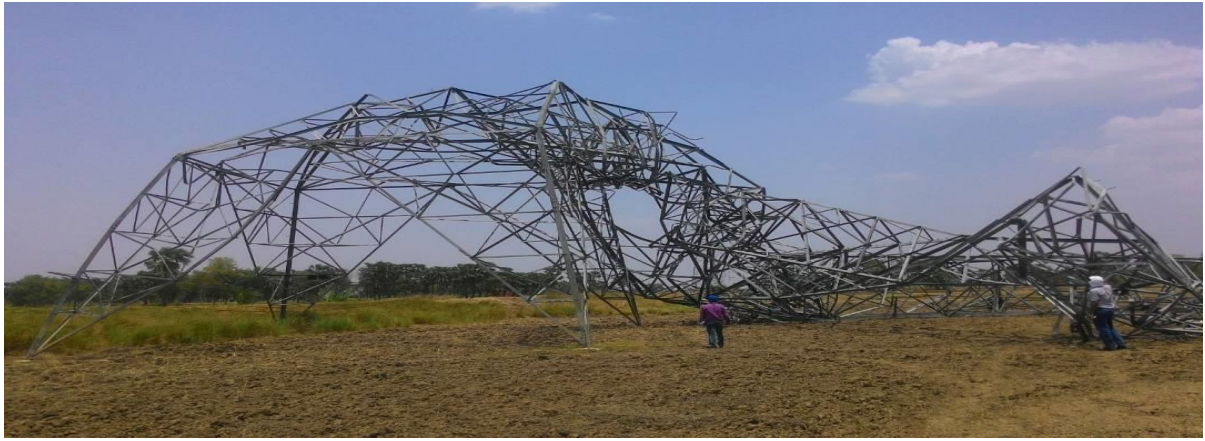
- b. **Tower at location No. AP 66 (A+0)** had bent and collapsed from the first section level, towards right side of the transmission line, when watched towards Gaya Substation. The tower members of the first section level were buckled and sheared. One of the Leg member of the tower and its stub got bent while other three stubs were intact. Foundations were found to be intact and were covered with sand. Some of the holes made for step bolts were left unplugged/unfilled.

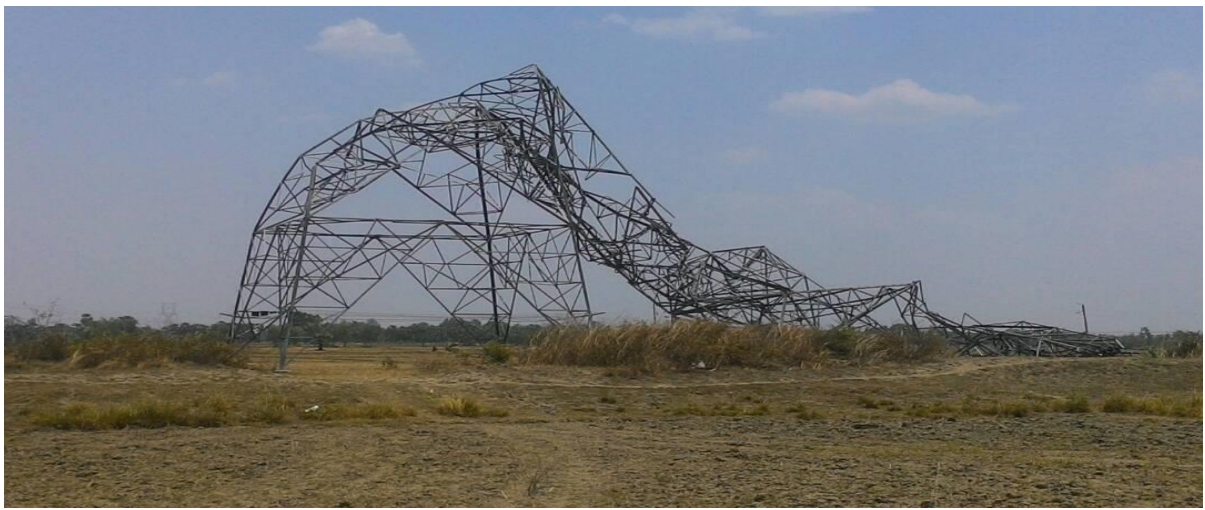
- c. **Tower at location no. AP 67(A+0)** was bent and collapsed from the first section level, towards right side of the transmission line, when watched towards Gaya Substation. All the stubs were found to be intact. The tower members of the first section level were bended and sheared. No damage was observed in the foundations.

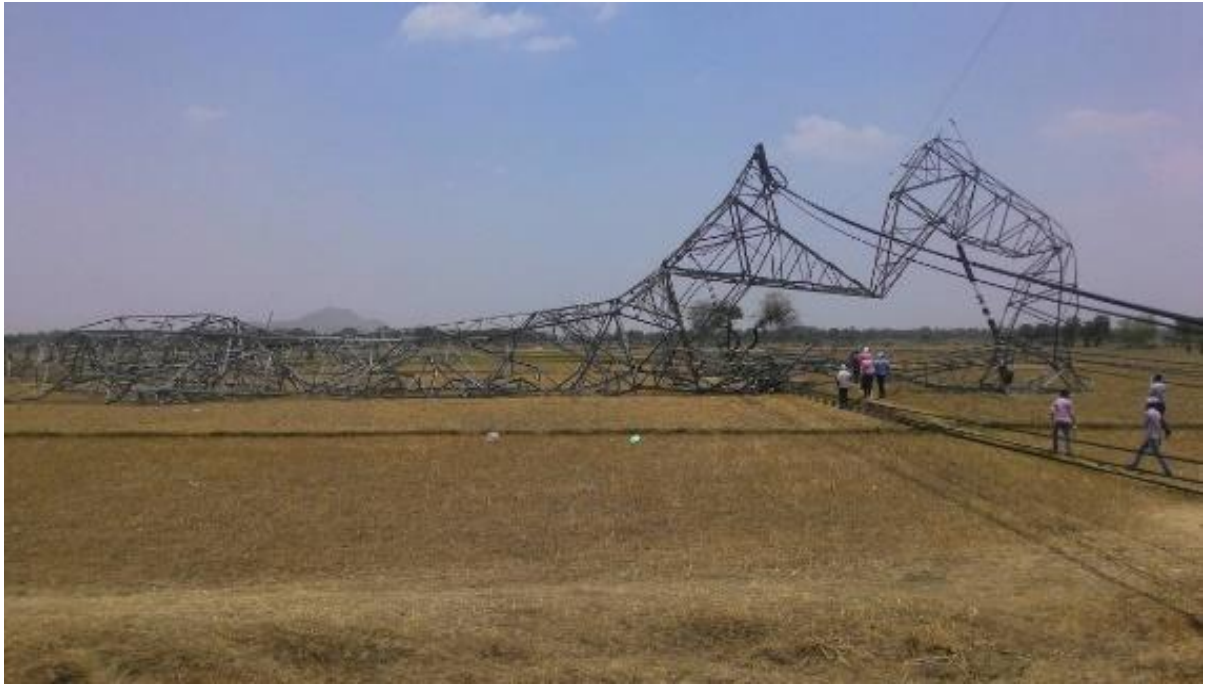
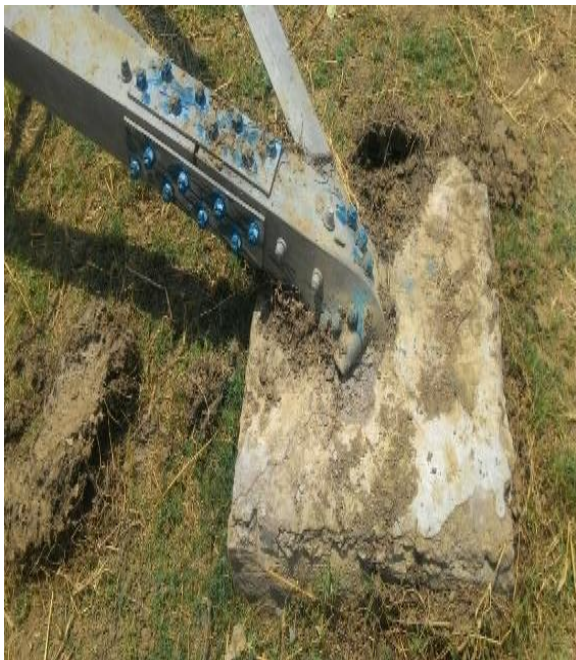
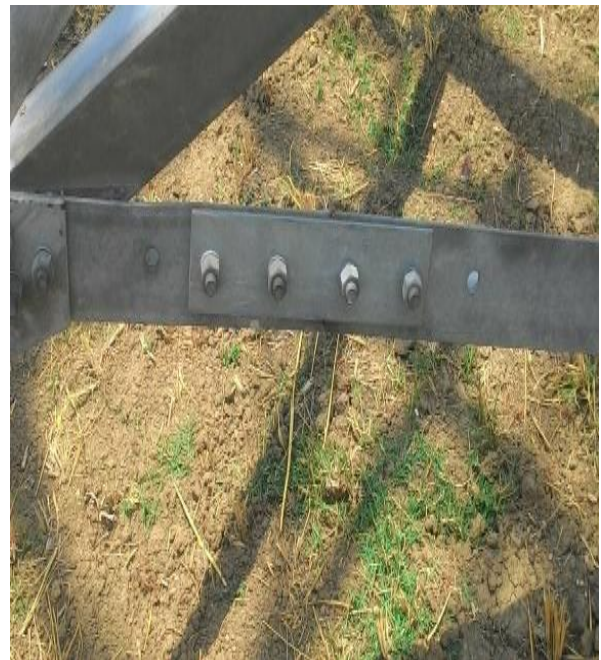
- d. **Tower at location no. AP 68 (A+ 0)** was completely collapsed from the stub level and was lying on the ground towards right side of the transmission line when watched towards Gaya Substation. All the four stubs were bent. Foundations were found to be intact and were covered with sand. It was observed that some of the holes made for step bolts were left unplugged/unfilled.

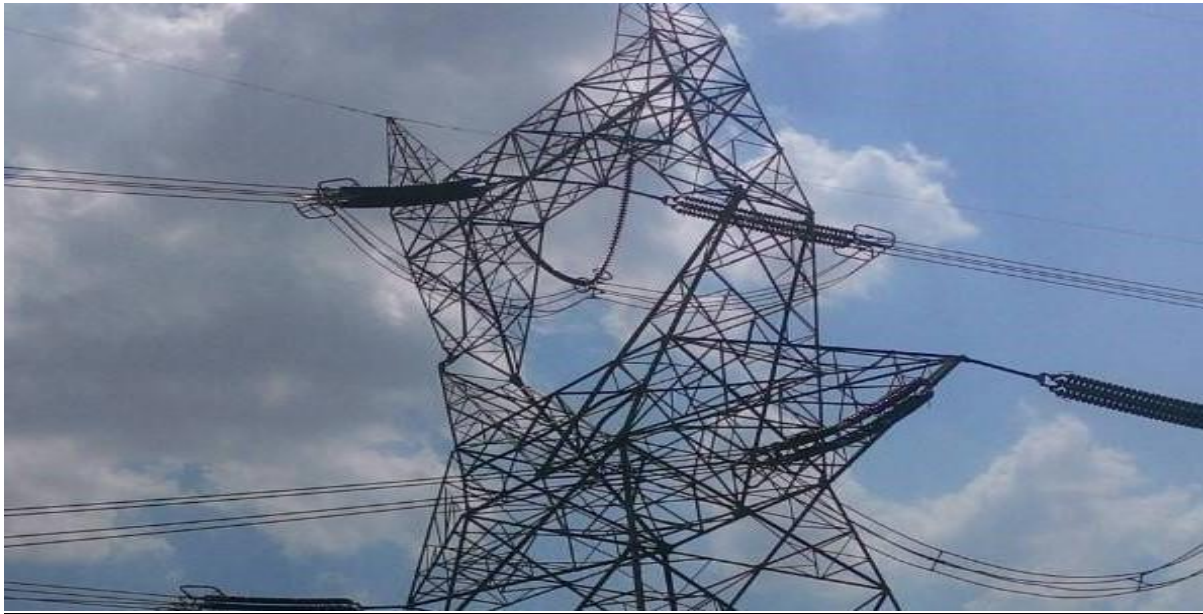
- e. **Tower at location no. AP 69 (C+0)** was in erect position. Two members of the delta section of the tower had buckled, and the tower body above them had tilted towards tower at location no. AP 68. Foundations were found to be intact and were covered with sand.

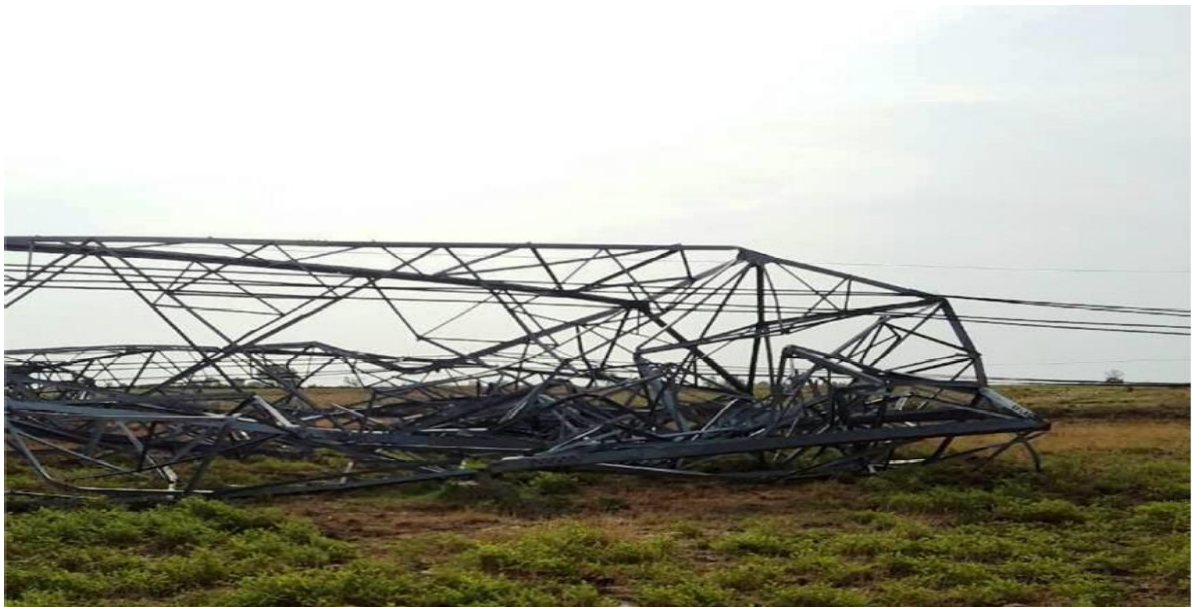
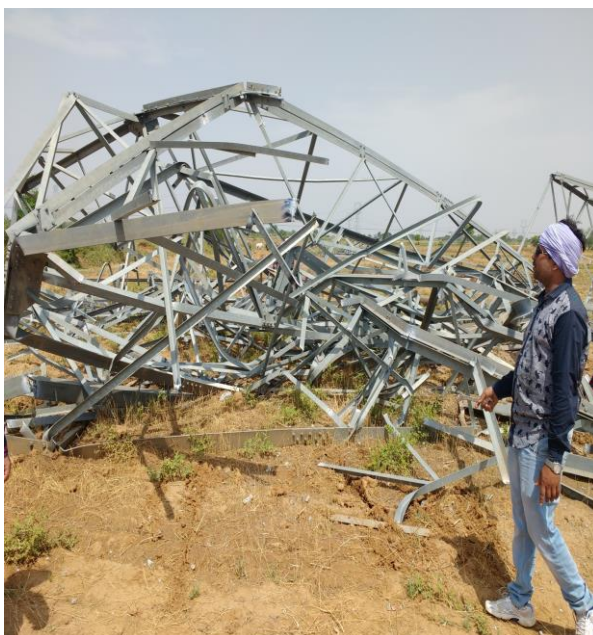
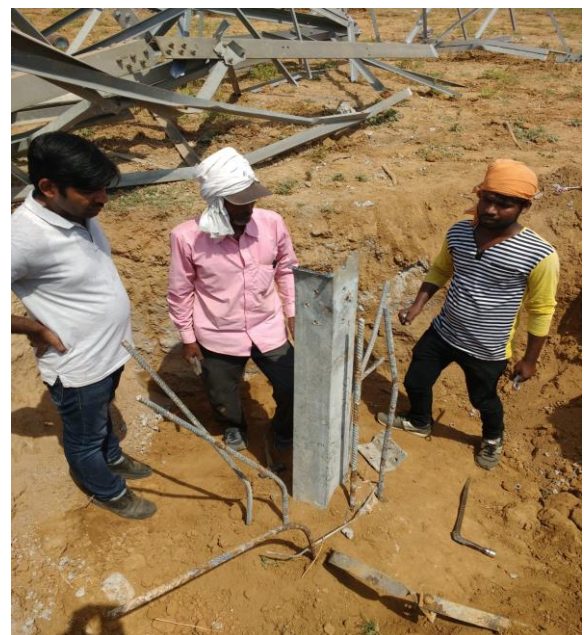
- a. **The tower at location No. 511** fell in the longitudinal direction towards tower location No. 512. Many tower members were found twisted. The tower was removed by gas cutting of all the four stubs at ground level and the peaks, cross arms etc. were detached from the tower body.

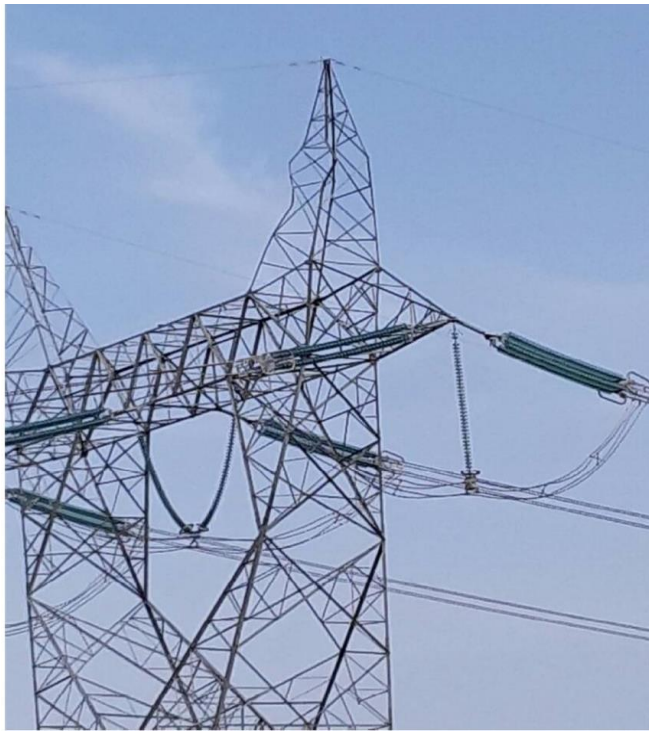
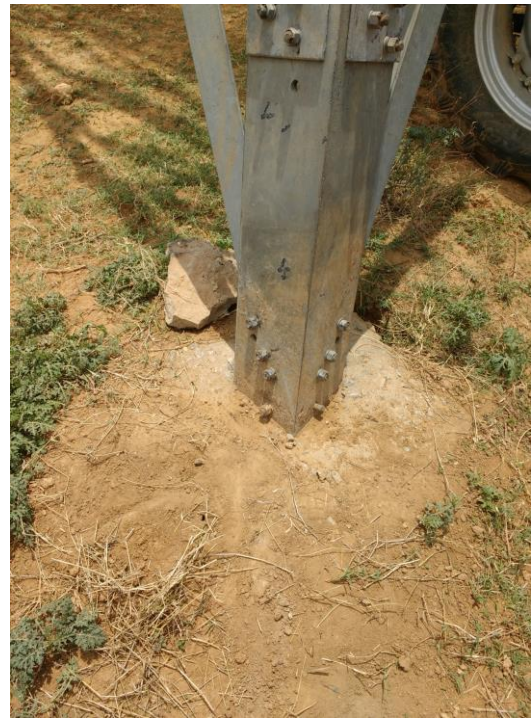
- b. **Tower location at No. 512** was damaged at one of the earthwire peak due to the collapse of tower at location No. 511. All the foundations were intact; however, coping of chimneys was not done properly resulting in rusting of the stubs. There were few dummy holes left in the leg joints connecting stubs which have not been plugged. Also, there were many bolts holes in the tie members.

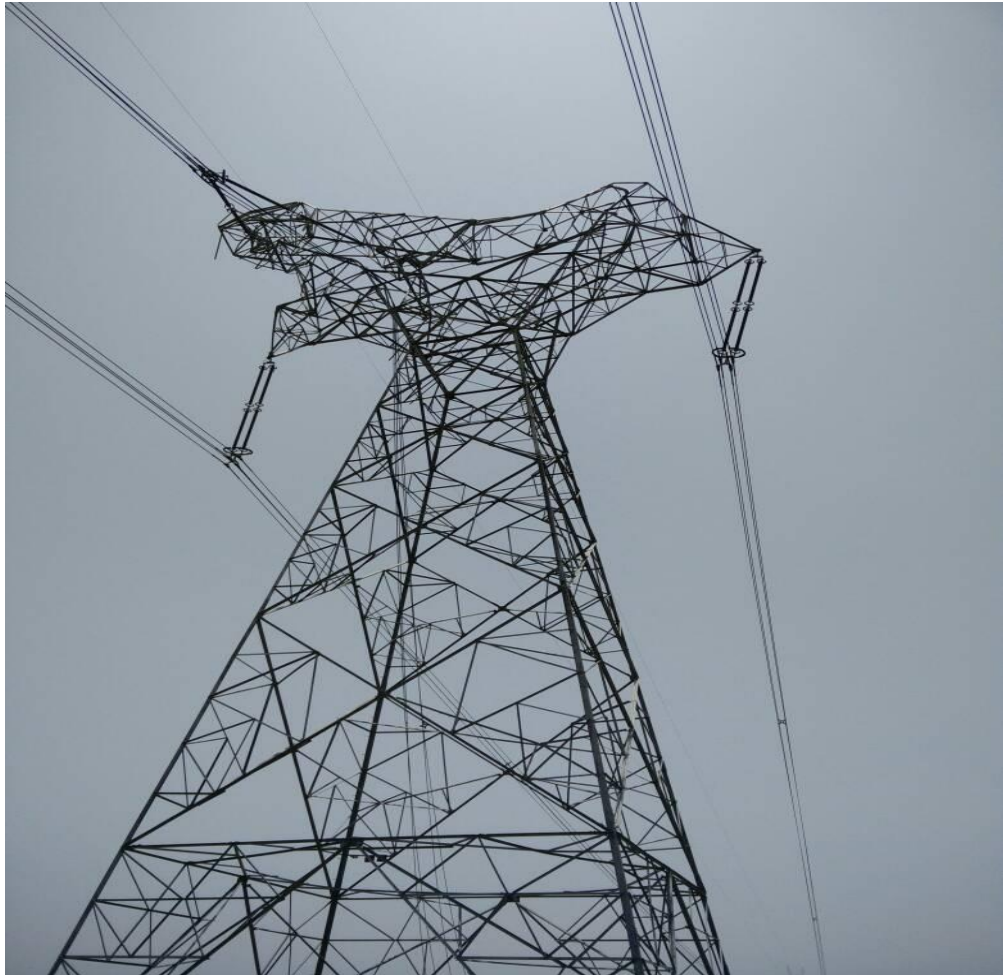
- a. **Tower at Loc. No. 506 (A+0)** was located in cultivated field with very few trees in the vicinity. Tower was in erect position and tower members at the delta section of tower were buckled and converged on the tower body. All the four stubs of the tower were intact. From the failure pattern, it appeared that this tower was collapsed due to pulling force of conductor generated due to failure of tower at Loc. No. 507.

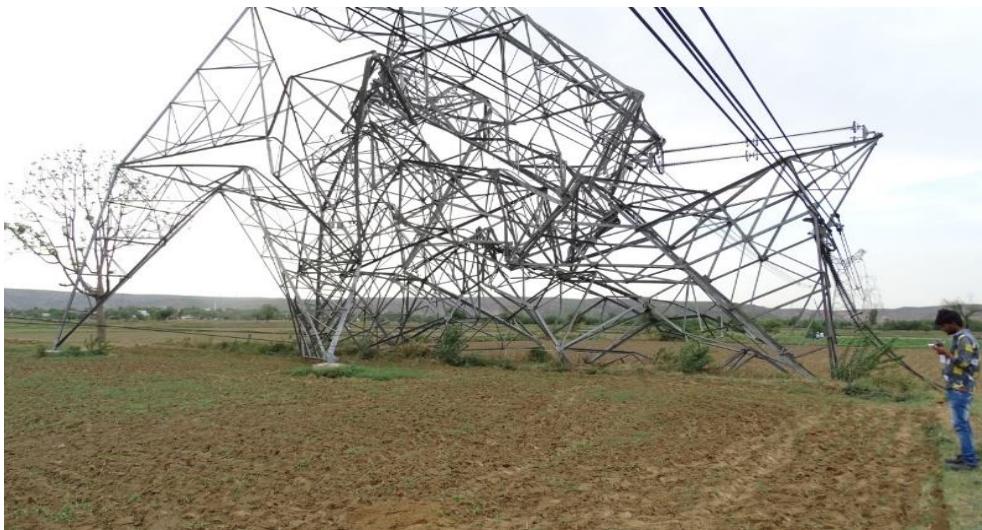
- b. **Tower at Loc. No. 507 (A+0)** was located in cultivated field with very few trees in the vicinity. Tower collapsed from first panel and two stubs of the tower were intact whereas two stubs of the tower were bent. From the failure pattern, it appears that failure was initiated from this tower.
