**REPORT OF THE STANDING COMMITTEE OF EXPERTS
ON FAILURE OF EHV TRANSMISSION LINE TOWERS
(OCTOBER 2016 – MARCH 2018)**

भारत सरकार
Government of India
केन्द्रीय विद्युत प्राधिकरण
Central Electricity Authority
विद्युत मंत्रालय
Ministry of Power
नई दिल्ली
New Delhi

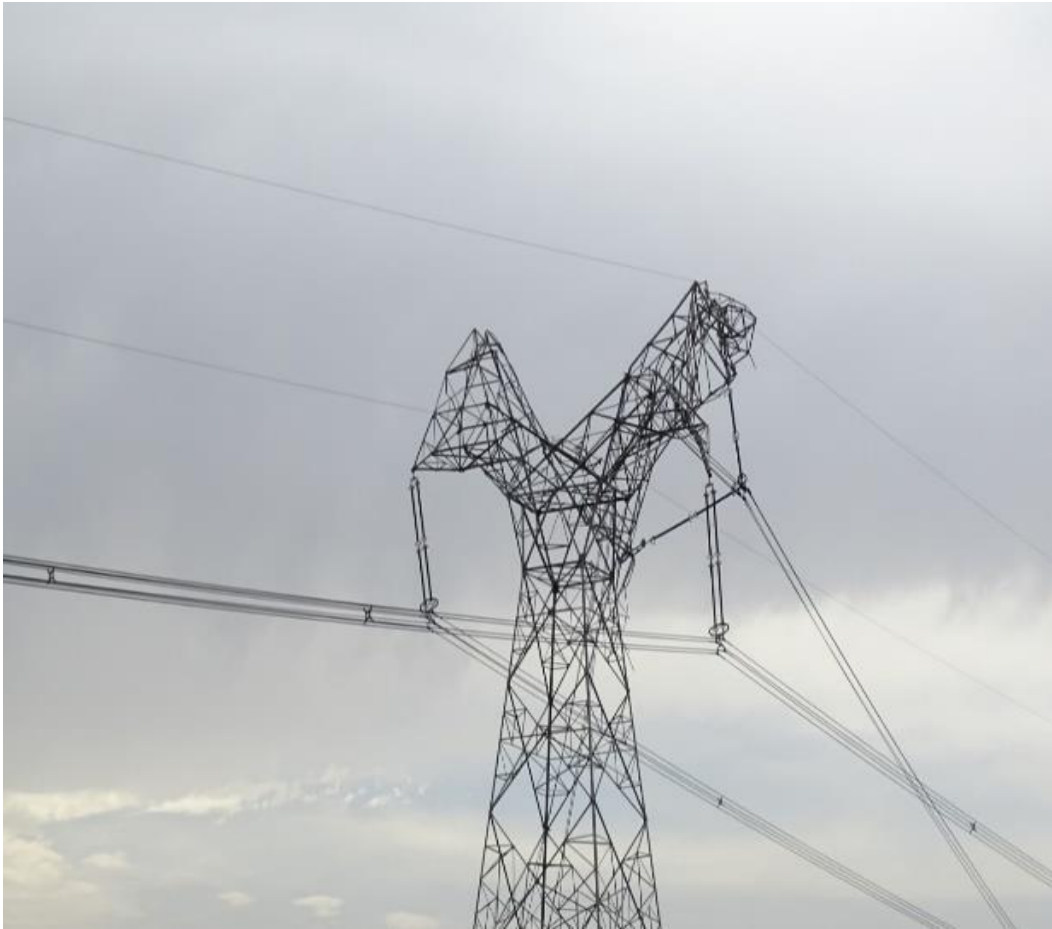
- c. **Tower at Loc. No. 508 (A+0)** was in erect position and all the four stubs of the tower are intact. The members of tower at cross arm level were bent and sheared and were resting on the

tower body. From the failure pattern, it appeared that this tower was collapsed due to pulling force conductor generated due to failure of tower at Loc. No. 507.

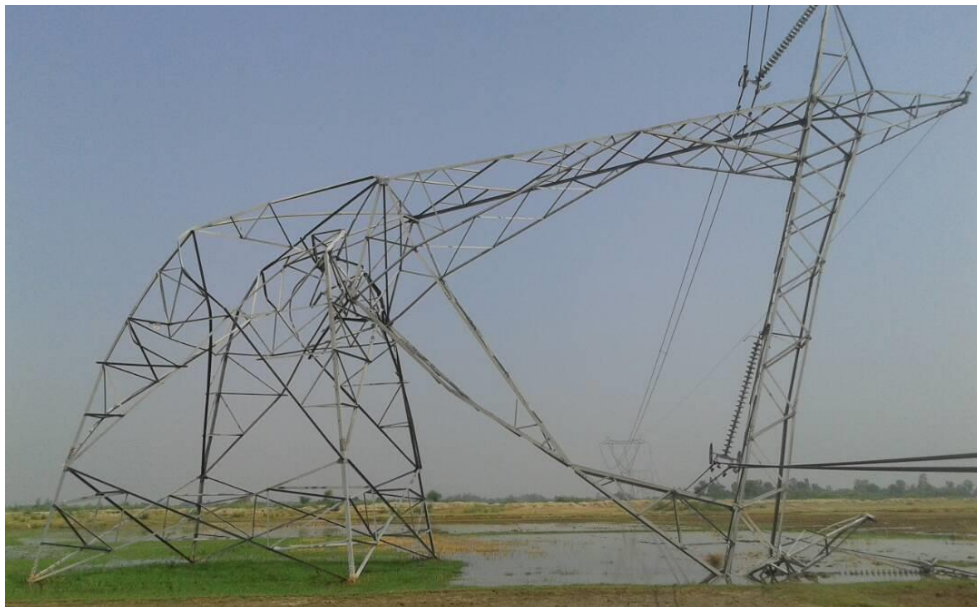
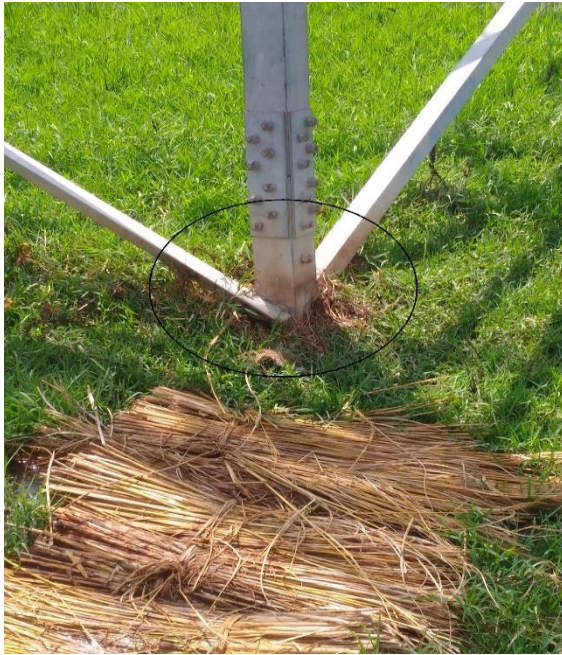
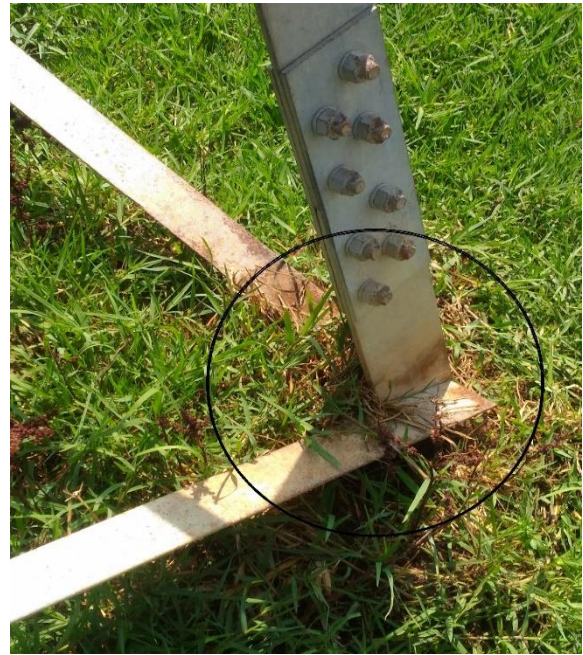
- a. **Tower at location no. 929 (A+3)** was collapsed above extension portion from the first panel in the transverse direction. The foundations of tower were not visible due to waterlogging and presence of grass around the base. Hence, the extent of damage to the foundations could not be ascertained. The failed tower was designed as per IS 802-1977 and was not strengthened by providing hip-bracing.

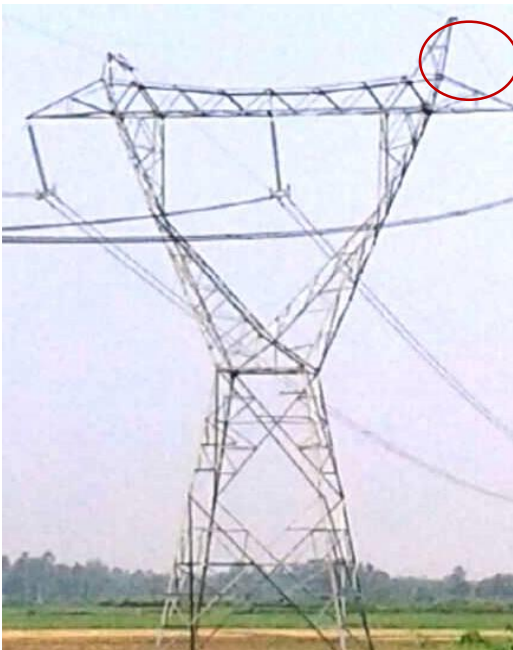
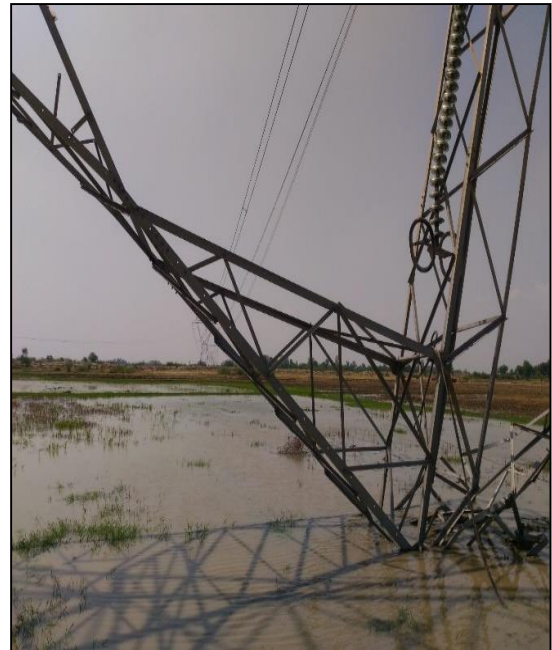
- b. **Tower at Loc. no. 930 (A+0)** One of the earth wire peak (left side) when seen from loc. 929, was damaged. However, rest of the tower was intact and no other damages were observed to any other members/stubs. Anti-climbing device was missing allegedly due to theft. PGCIL Officials informed that theft was frequent in the area. Holes in few members were left unplugged.

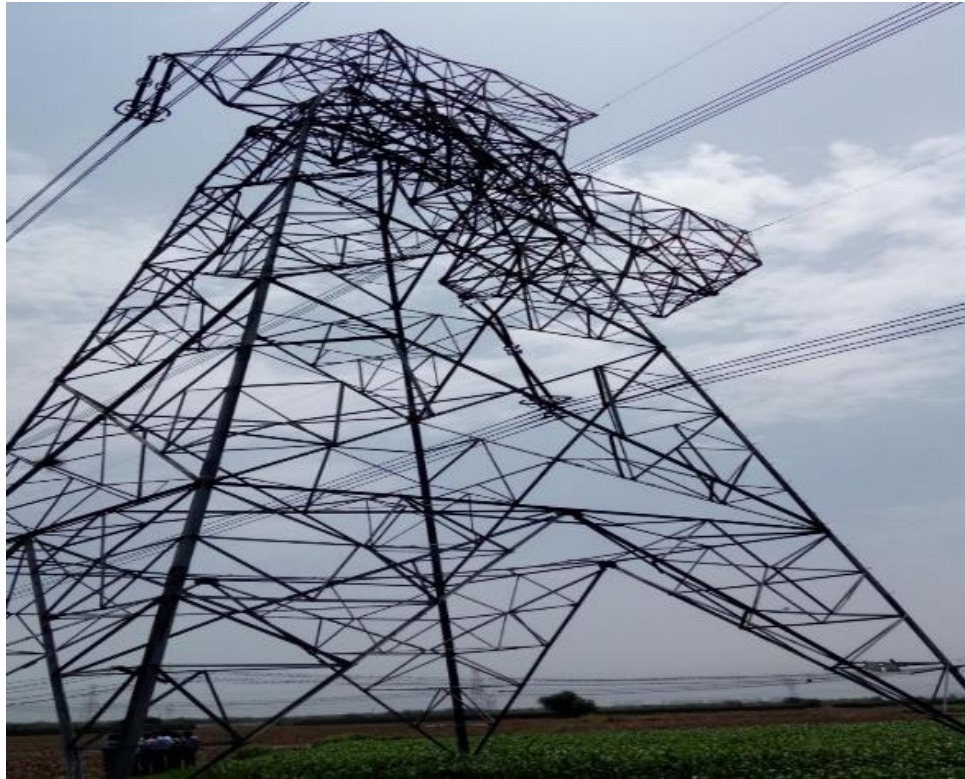
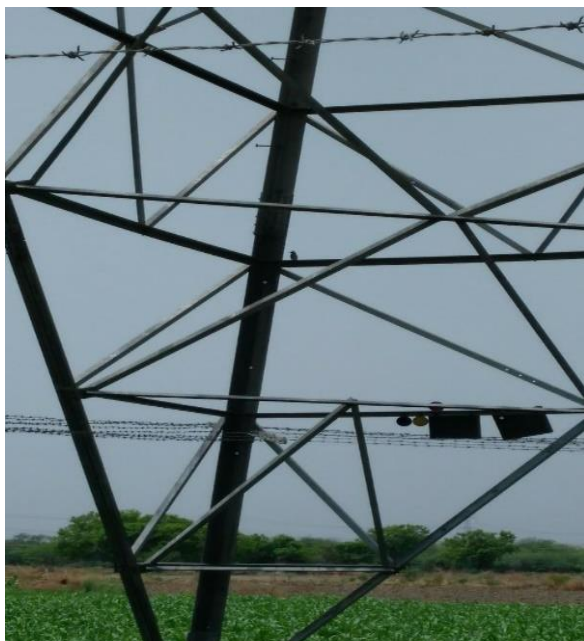
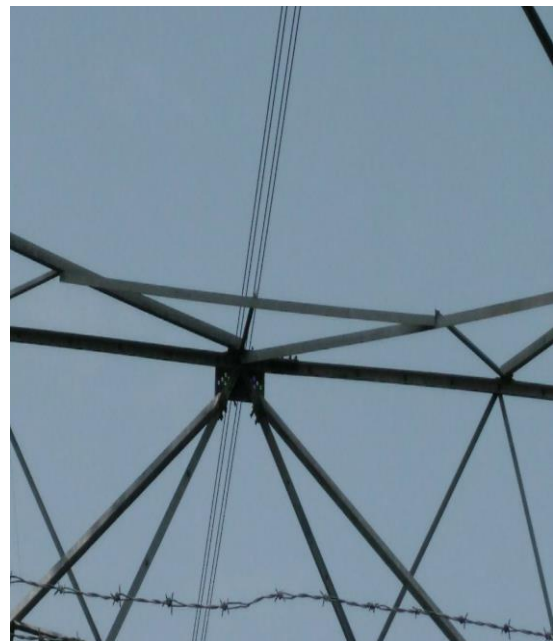
numbers of holes in some of the members were left unplugged. Coping of one of the chimney was not done. The holes made for step bolts and in universal connection plate, used for connecting bracings, were left unplugged. No damage was reported in two other transmission lines of 765 kV level namely, 765 kV Kanpur-Jatikara transmission line (Vertical configuration) and 765 kV Agra-Jhatikara transmission line (Delta configuration) traversing in the vicinity of the location of the failed tower. PGCIL officials were requested to submit wind data of nearby IMD observatory for 19.06.2017. No information was provided in this regard.

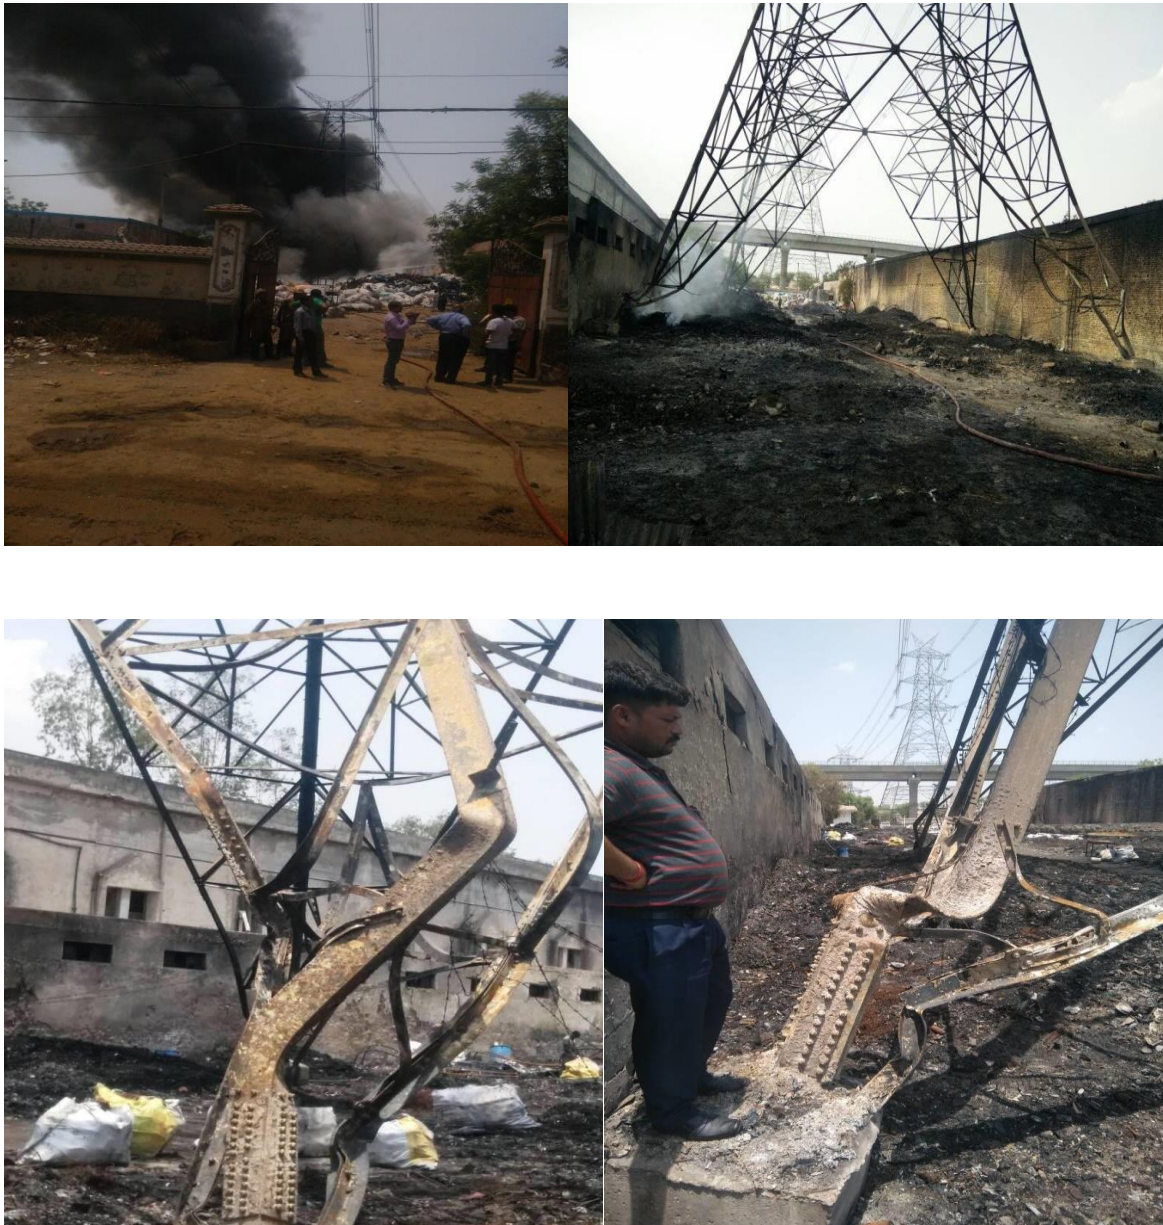
As per the report submitted by DTL, the tower at location No. 116 of 400 kV Tikrikalan-Bawana transmission line got damaged due to intense fire underneath the tower on 14.05.2017. The leg members of tower were bent and damaged. However, the tower was in erect condition due to pull force of conductor on either side of tower. The fire was caught by plastic waste present underneath the tower causing a high temperature and subsequently bulging of tower leg members. Adjacent tower span was crossing NH-10 and DMRC elevated corridor. The foundations of legs were found intact.

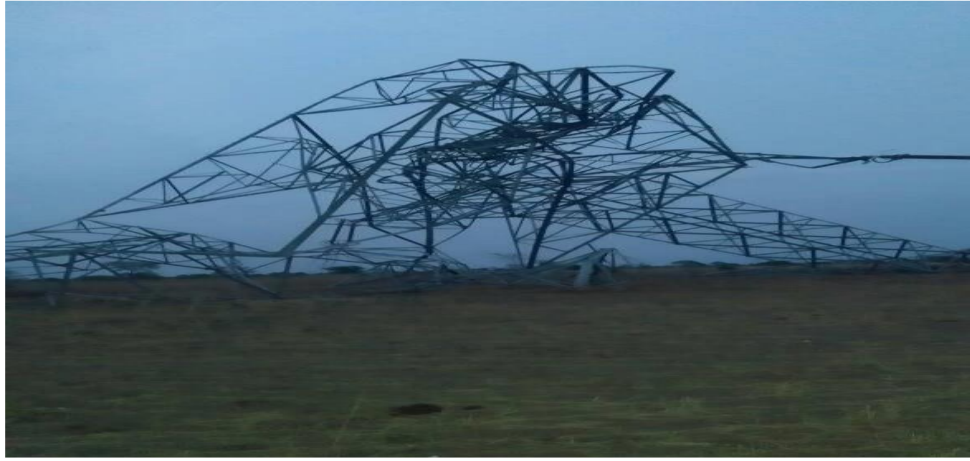
- b. **Tower at Location no 110/8 (A+0):** Tower was in erect condition. Both (left & right) bottom cross-arm got bent. The foundations were intact.
- c. **Tower at Location no 110/9 (A+0):** The tower was completely collapsed.

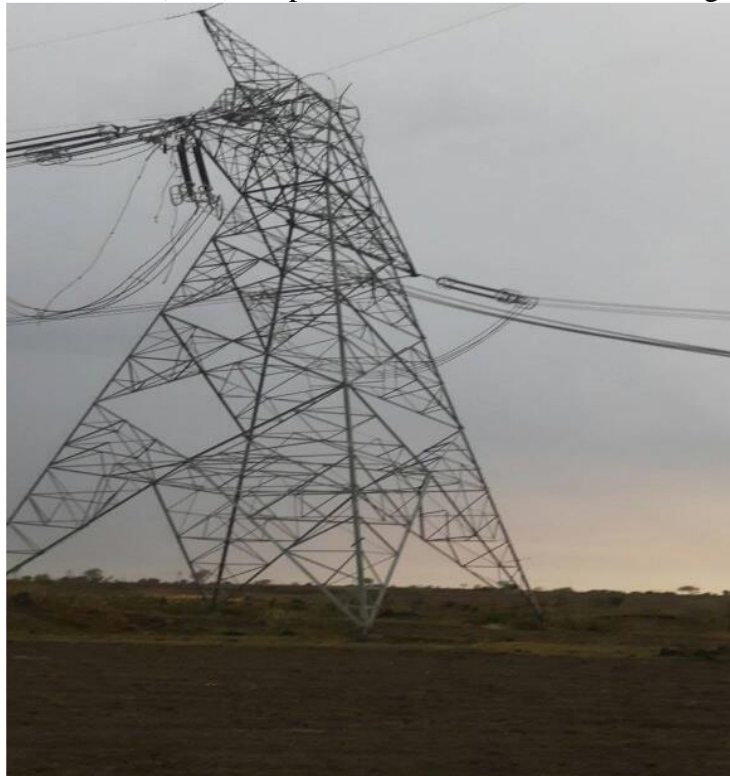
- e. **Tower at Location no 111/0 (C+0):** Top to middle section of the tower got bend.

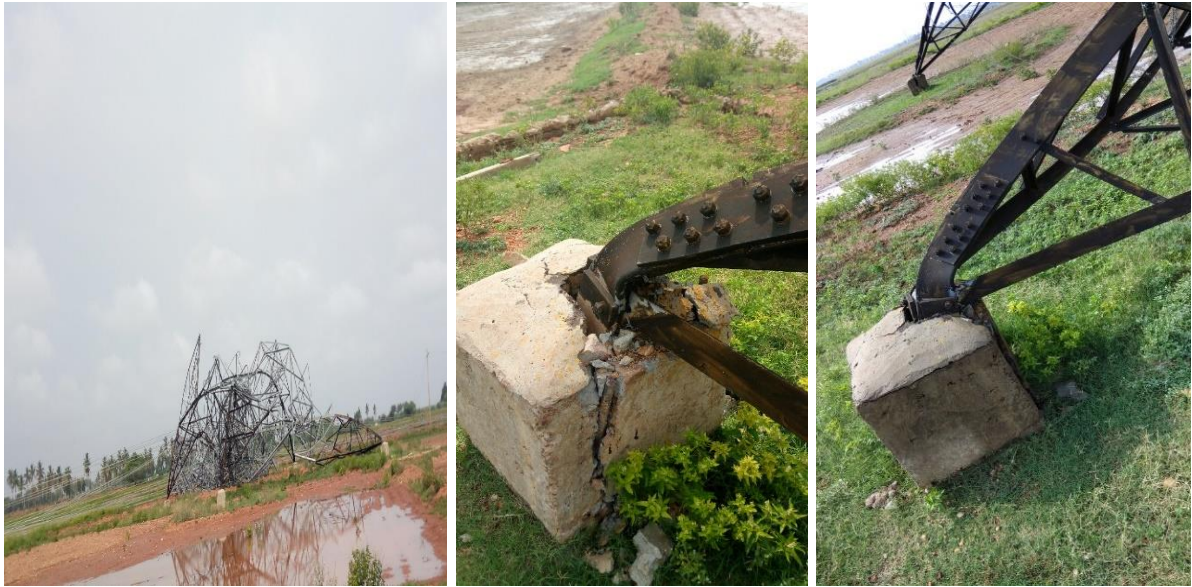
- b. **Tower at loc. No. 27/3(DS+0)** was collapsed completely & was laying on the ground. All four stubs got bent. Cracks were seen in the foundation chimney above ground level & reinforcing bars were exposed.

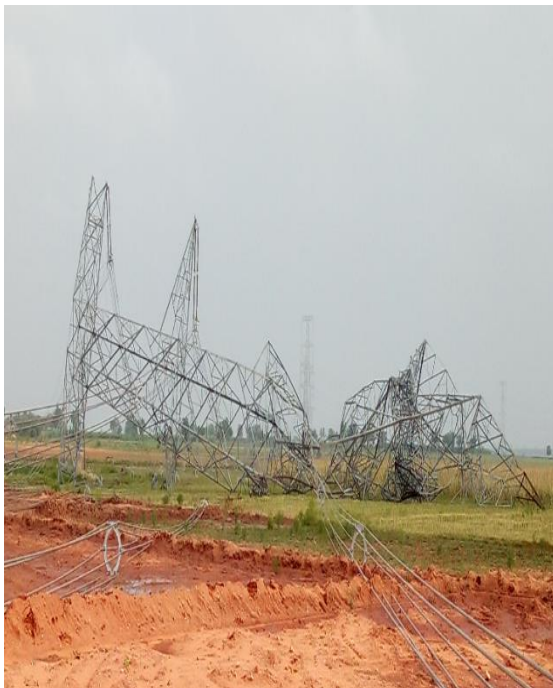
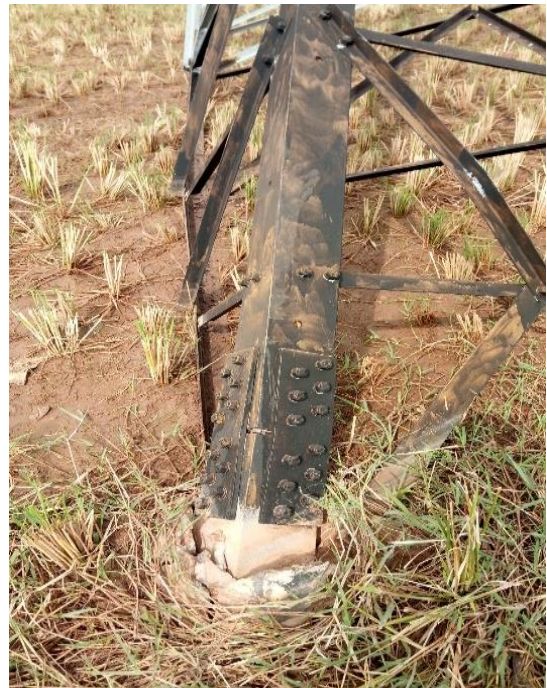
- c. **Tower at loc. No. 27/4 (DS+0)** was collapsed fully & was laying on the ground. All four stubs got bent & laid down along with the tower. Cracks were seen in the foundation chimney above ground level.
