**REPORT OF THE STANDING COMMITTEE OF EXPERTS
ON FAILURE OF EHV TRANSMISSION LINE TOWERS
(OCTOBER 2016 – MARCH 2018)**

भारत सरकार
Government of India
केन्द्रीय विद्युत प्राधिकरण
Central Electricity Authority
विद्युत मंत्रालय
Ministry of Power
नई दिल्ली
New Delhi

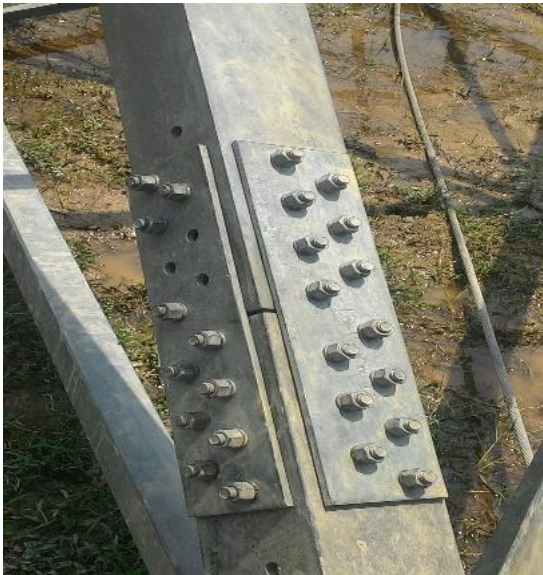
- a. **Tower at location no. 124(DA+0)** was located in plain terrain and completely collapsed to the ground from the stub level in transverse direction. All the 4 stubs got damaged. Three of the chimneys were broken. Coping of the chimneys was not done & Steel reinforcement got exposed in the chimneys. The tower was in water logged area and foundations of the tower

were partially submerged in water. Tack welding of the bolts was not done and some of the bolts in butt joints in leg members were missing. Few numbers of holes were left unfilled in some members of the tower. Anti-climbing device was not provided.

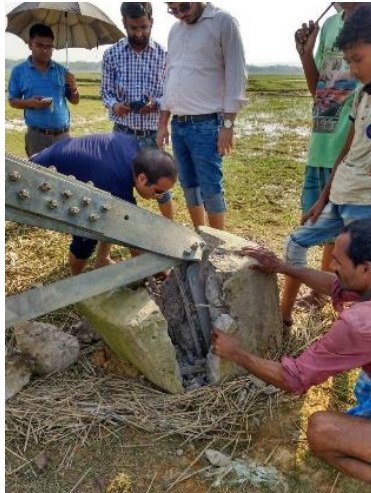
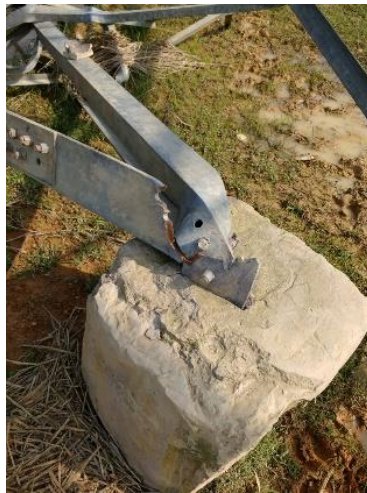
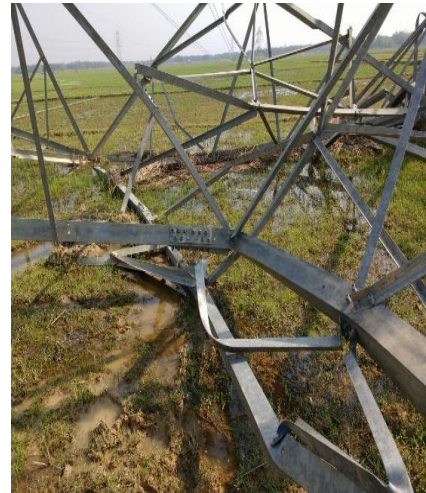
- f. **Tower location no. 137 (DA+0)** fell in the transverse direction. All the stubs of tower were bent and Two chimneys were broken. Many bolts were missing in the joints of leg members. ACD was not available. Extra holes in the main leg members were not plugged. One of the stub was sheared. Coping of the chimneys was not done properly.

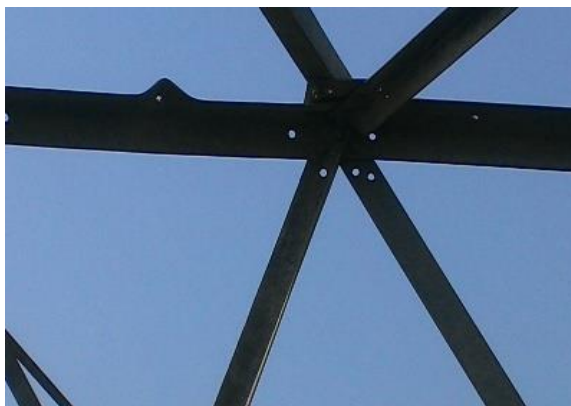
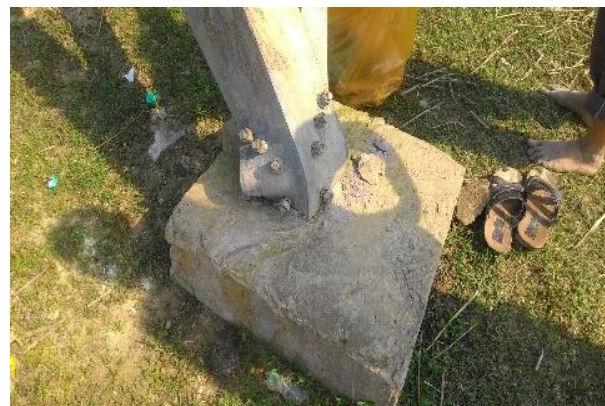
- g. **Tower at location no. 138 (DA+0)** had collapsed from the stub level towards left side when observed facing P K Bari. Unplugged holes were present in the members of the tower which were. Coping of the chimneys were not done. Two stubs were bent & other two were intact. Few numbers of bolts in the joints of bracings and leg members were missing. Anti-climbing device was not provided. The area surrounding the failed tower was water logged.

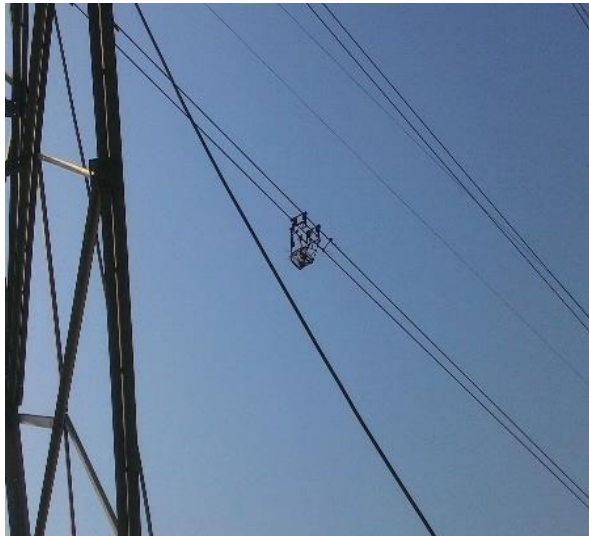
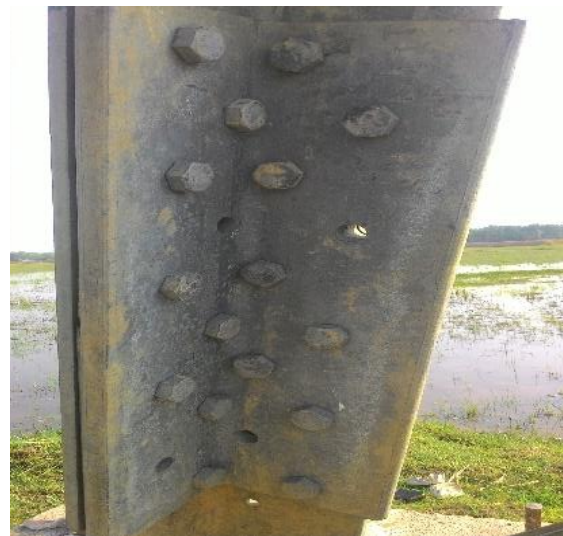
- h. **Tower at location no. 139 (DD+0)** was in erect position with members above bottom cross arm level twisted and bent towards right side in transverse direction when observed facing P K Bari. Members above first section got buckled & the foundations were intact. Coping of chimneys was not done. Steel reinforcement was protruding from three of the chimneys. A number of holes in tower members were not plugged. Few numbers of bolts were missing in

the leg member joints. A trolley which might have been used while stringing the conductors was not removed from the wires and was still hanging in air. The line was charged without removing this trolley.

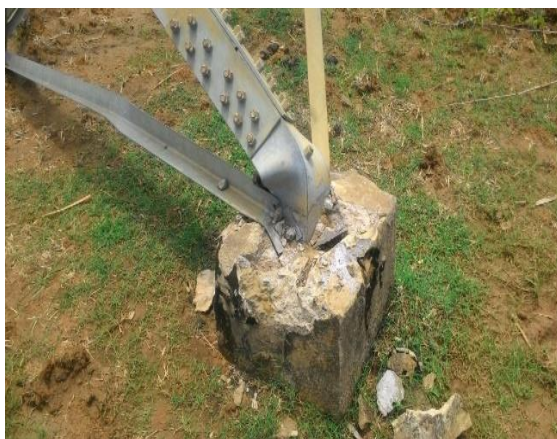
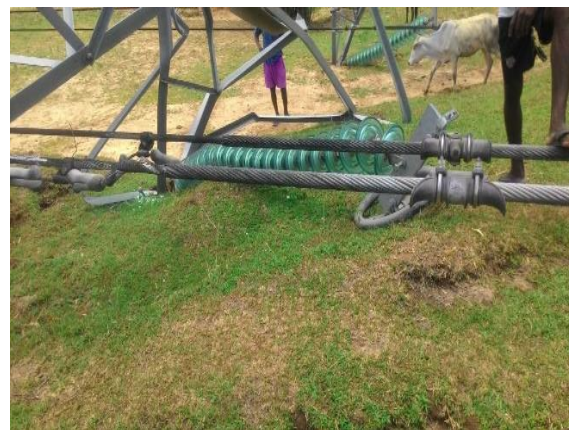
- b. **Tower at location no. AP 143 (DA+0)** was completely collapsed in transverse direction towards right side of the transmission line when watched towards Farakka Substation and was lying on the ground. Three of the stubs were bent and the fourth stub got bent and sheared. Anti-climbing device was not provided. Signs of flash over at right bottom cross arm insulator were observed. Minor damages were observed in one of the chimneys. The foundations were found to be intact.

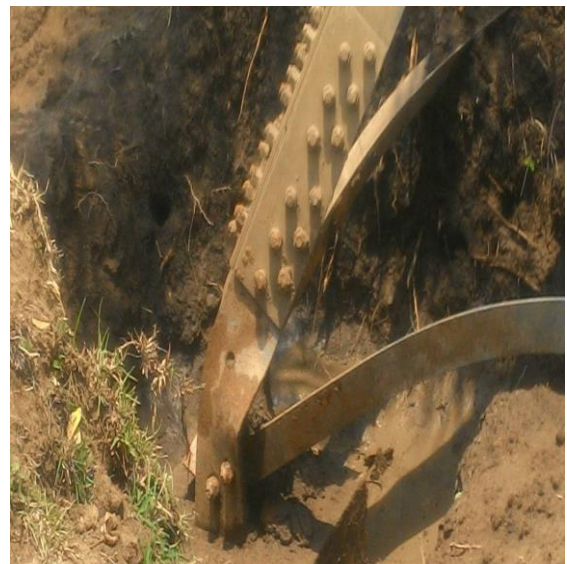
- c. **Tower at location no. AP 144 (DA+6)** was completely collapsed towards right side of the transmission line when watched towards Farakka Substation and was lying on the ground. Three of the stubs were bent and fourth stub was not visible as it was under the ground. It was

observed that three of the tower legs were recently excavated. The members of the leg and connecting bracings were rusted. Anti-climbing devices was not provided. The foundations were found to be intact.

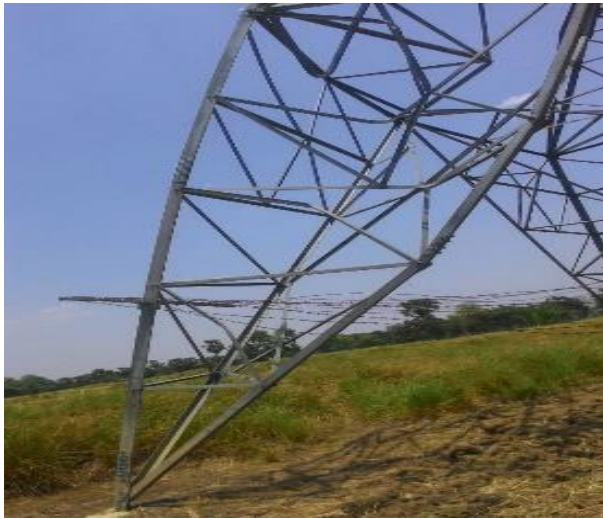
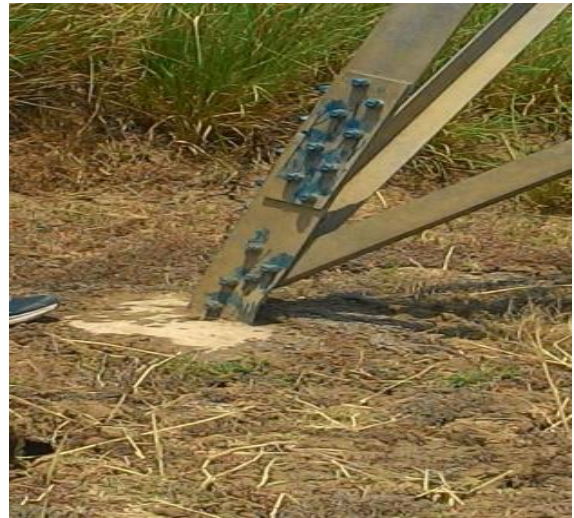
- b. **Tower at location No. AP 66 (A+0)** had bent and collapsed from the first section level, towards right side of the transmission line, when watched towards Gaya Substation. The tower members of the first section level were buckled and sheared. One of the Leg member of the tower and its stub got bent while other three stubs were intact. Foundations were found to be intact and were covered with sand. Some of the holes made for step bolts were left unplugged/unfilled.

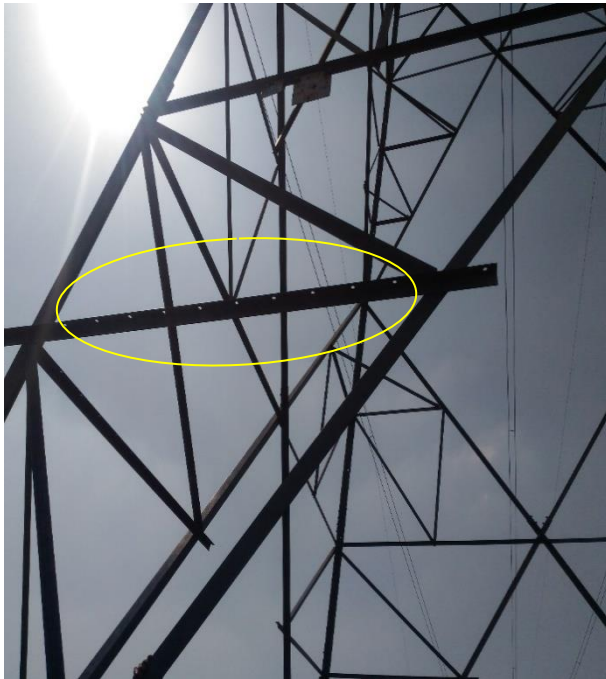
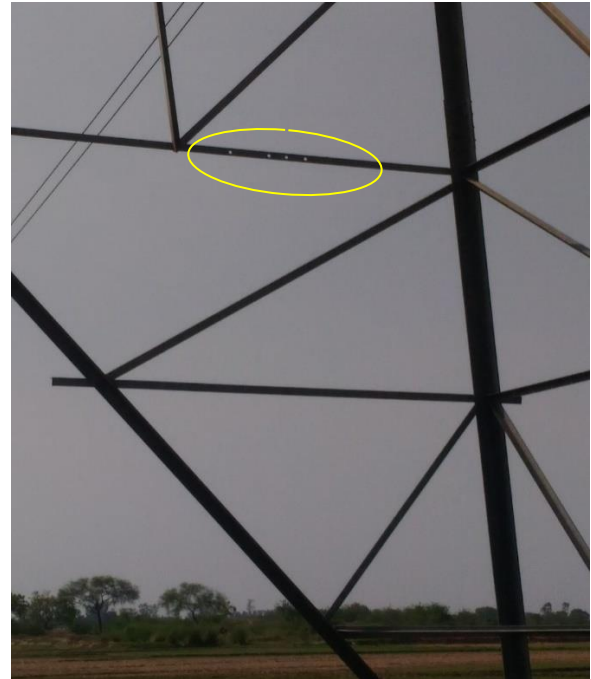
- b. **Tower at Loc. no. 930 (A+0)** One of the earth wire peak (left side) when seen from loc. 929, was damaged. However, rest of the tower was intact and no other damages were observed to any other members/stubs. Anti-climbing device was missing allegedly due to theft. PGCIL Officials informed that theft was frequent in the area. Holes in few members were left unplugged.

The committee noted that this line was designed as per IS 802-1977 and was not strengthened by providing hip bracing in the bottom most panels. Absence of hip bracing with a large number of unplugged holes might have made the tower vulnerable and combined with localized wind storm might have caused the failure of tower at location No. 929 and damage to the ground wire peak of tower at location No. 930 was secondary failure. The high wind velocity might have induced the failure of towers but it may not be the sole reason for the occurrence of the incident.

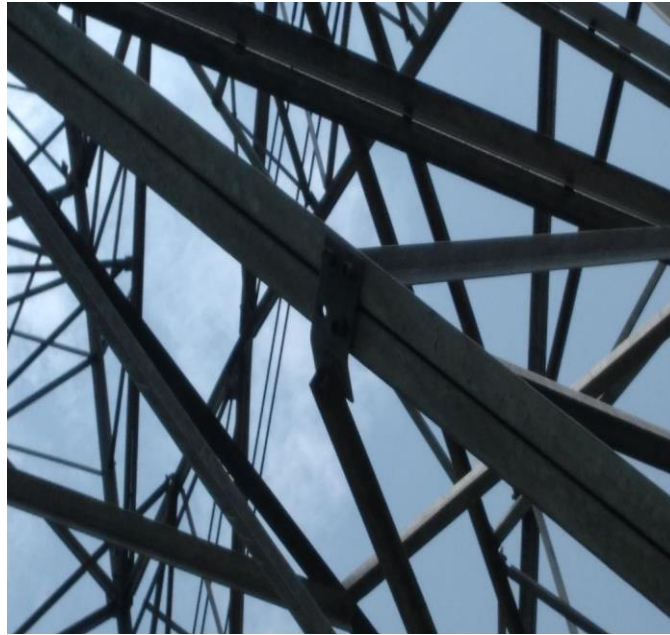
numbers of holes in some of the members were left unplugged. Coping of one of the chimney was not done. The holes made for step bolts and in universal connection plate, used for connecting bracings, were left unplugged. No damage was reported in two other transmission lines of 765 kV level namely, 765 kV Kanpur-Jatikara transmission line (Vertical configuration) and 765 kV Agra-Jhatikara transmission line (Delta configuration) traversing in the vicinity of the location of the failed tower. PGCIL officials were requested to submit wind data of nearby IMD observatory for 19.06.2017. No information was provided in this regard.

The 765 kV S/C Jatikara-Bhiwani transmission line with delta configuration was erected using same tower design as in the 765 kV Gaya-Fatehpur S/C transmission line (Wind Zone-4) with Delta configuration. The failure of these 765 kV delta configuration suspension type towers had been investigated by the Standing Committee of Experts for investigating failure of transmission line towers in the year 2015. Design review analysis of this type of tower of PGCIL was carried out CPRI on directions of the Standing Committee and strengthening of few members above waist level by replacing existing members with new members were proposed. The failed tower had not been strengthened and were vulnerable and in addition high intensity localized wind conditions might have prevailed in the vicinity of transmission line with wind blowing in the transverse direction of line which initiated the failure of tower.

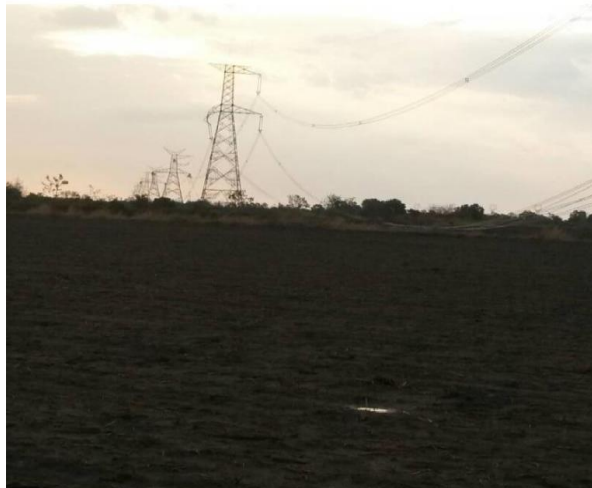
Loc. No. 110-7

- a. **Tower at Location no 110/7 (A+0):** Tower was in erect condition. All the three cross-arm of the tower got bent. The foundations were intact.

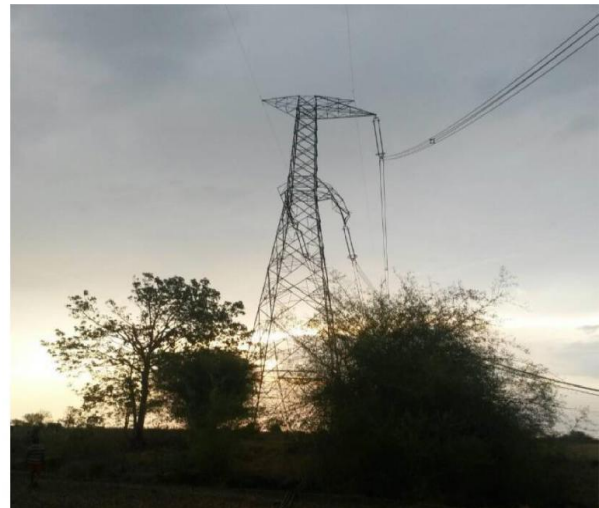
Loc. No. 110-8

- b. **Tower at Location no 110/8 (A+0):** Tower was in erect condition. Both (left & right) bottom cross-arm got bent. The foundations were intact.
- c. **Tower at Location no 110/9 (A+0):** The tower was completely collapsed.

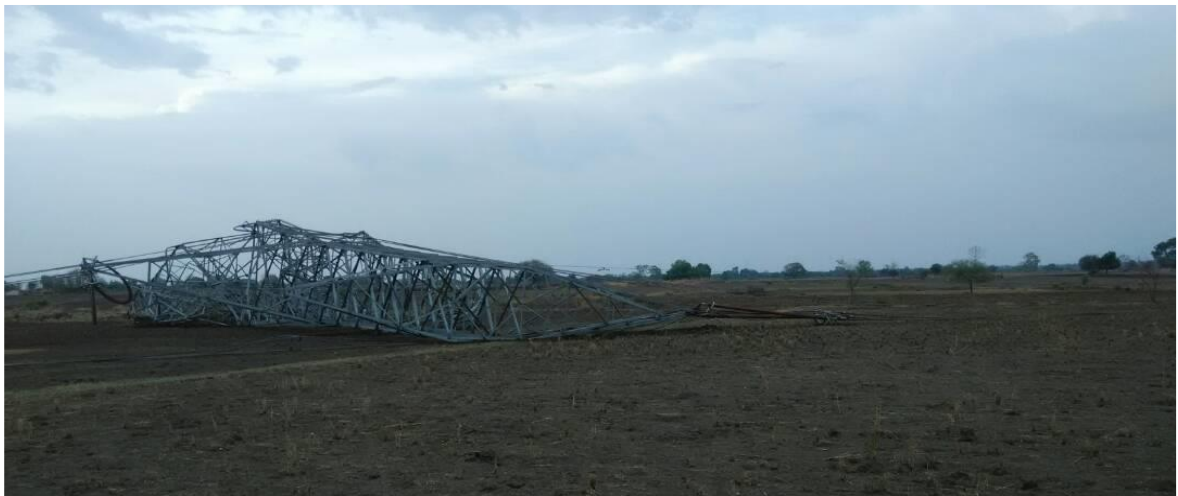
- d. **Tower at Location no 110/10 (A+0):** The tower was completely collapsed.

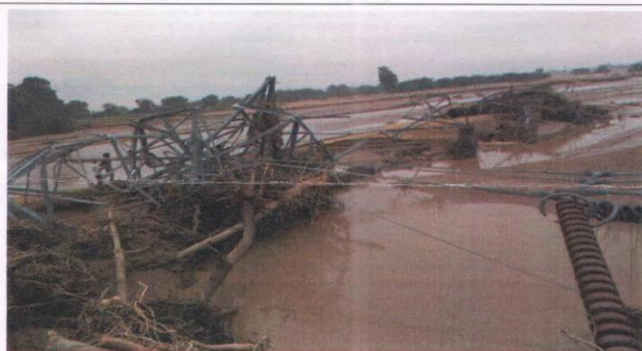
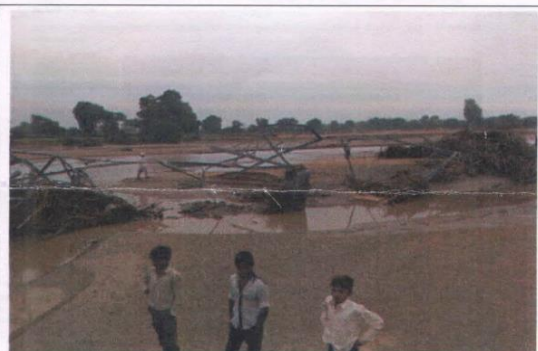
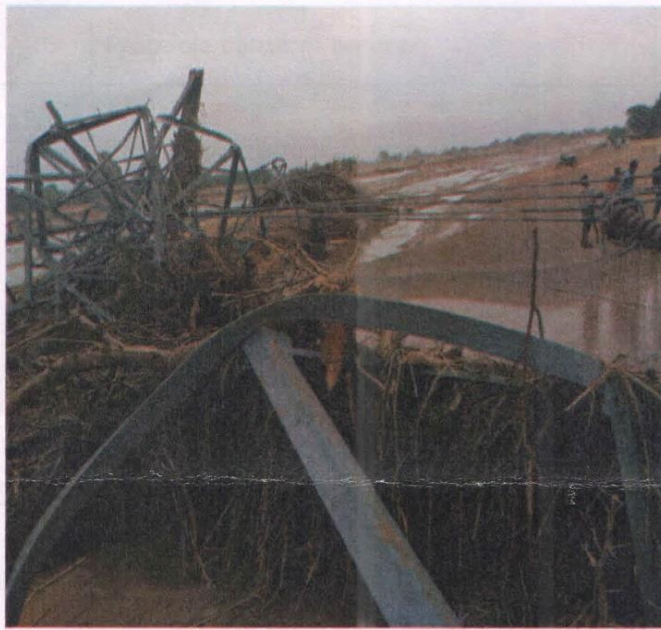
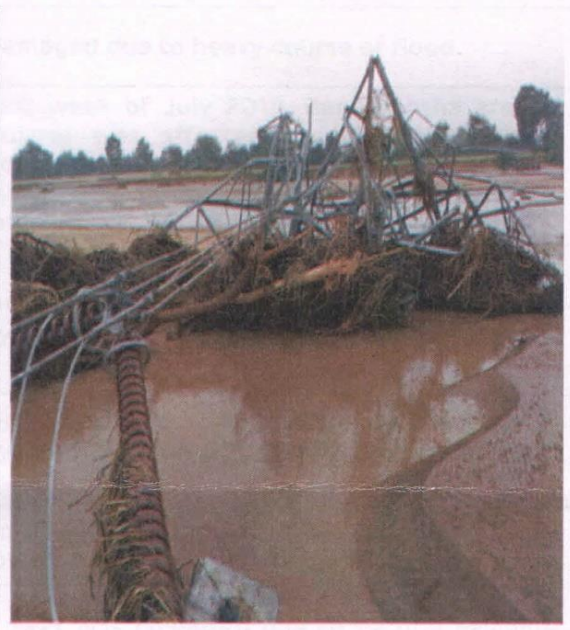
Tower at location no. 941(DA+0) was collapsed completely to the ground. As reported in investigation report submitted by M/s ATL, the failure of tower occurred on 24.07.2018 but due to flood like conditions the repair team could reach the locations on 26.07.2108. The tower foundations were severely damaged and were displaced from original locations. Earthwire and OPGW peak of the adjacent tower was also damaged due to pulling force of conductors.

Committee noted new water course was created due to heavy rains. Improper anticipation of change in river course, lack of provision of Pile type foundation & Proper Protection (retaining wall, Gabion wall etc.) for towers near the river was observed as cause of failure.

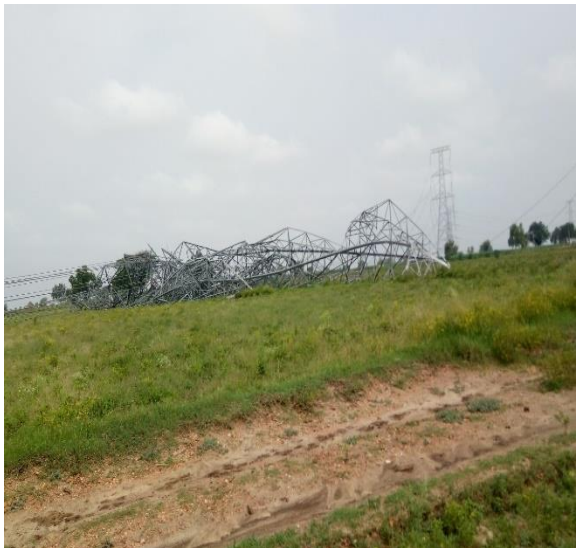
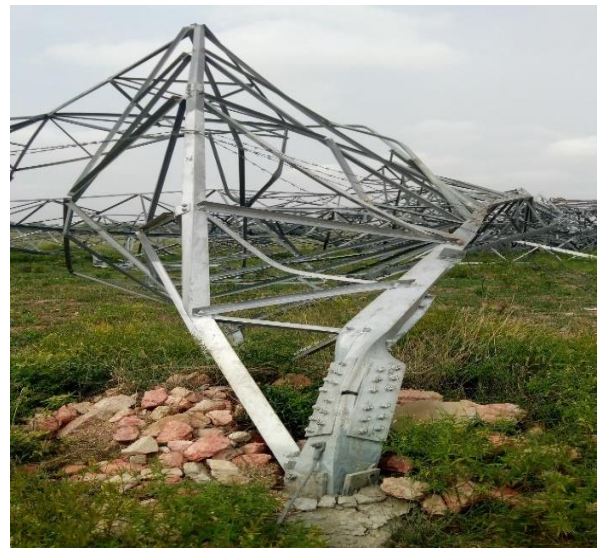
- a. **Tower at loc. No. 27/2(DS+0)** was collapsed completely & laid on the ground. All four Stubs got bent & broken. Cracks were observed in the foundation chimney above ground level.

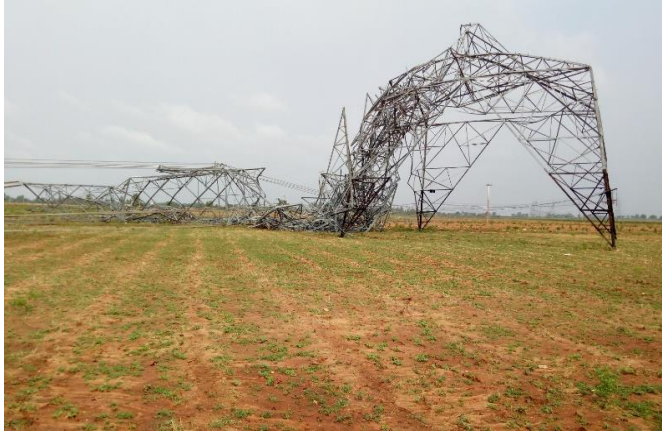
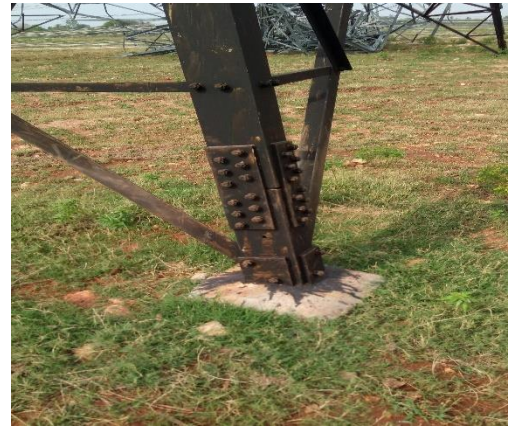
- d. **Tower at Loc. No. 27/5 (DS-1.5)** was collapsed from first panel and above. All four stubs & foundation were found intact.

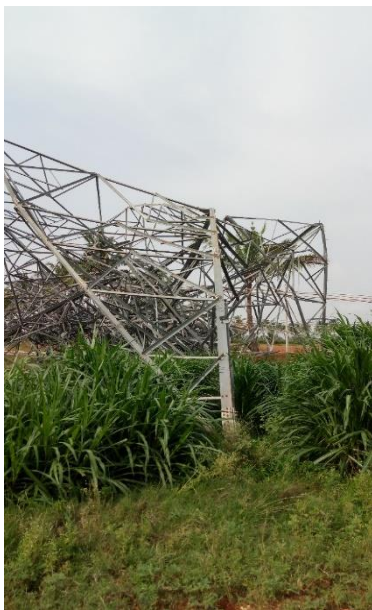
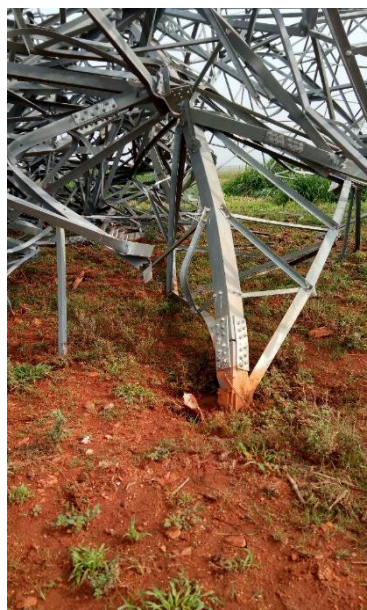
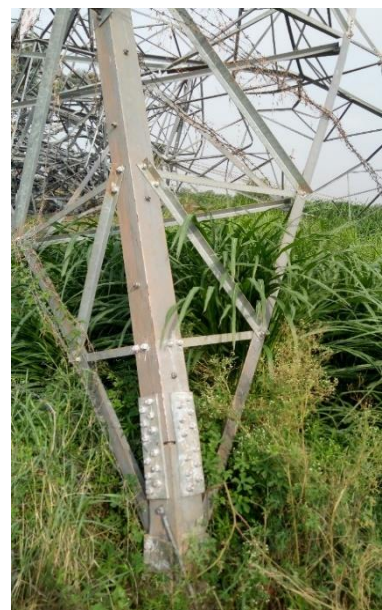
- e. **Tower at Loc. No. 27/6(DS+0)** was collapsed completely & was laying on the ground. All four stubs got bent. Cracks were observed in the foundation chimney above GL.
